Basic Analysis Tools

2-Stroke Analysis

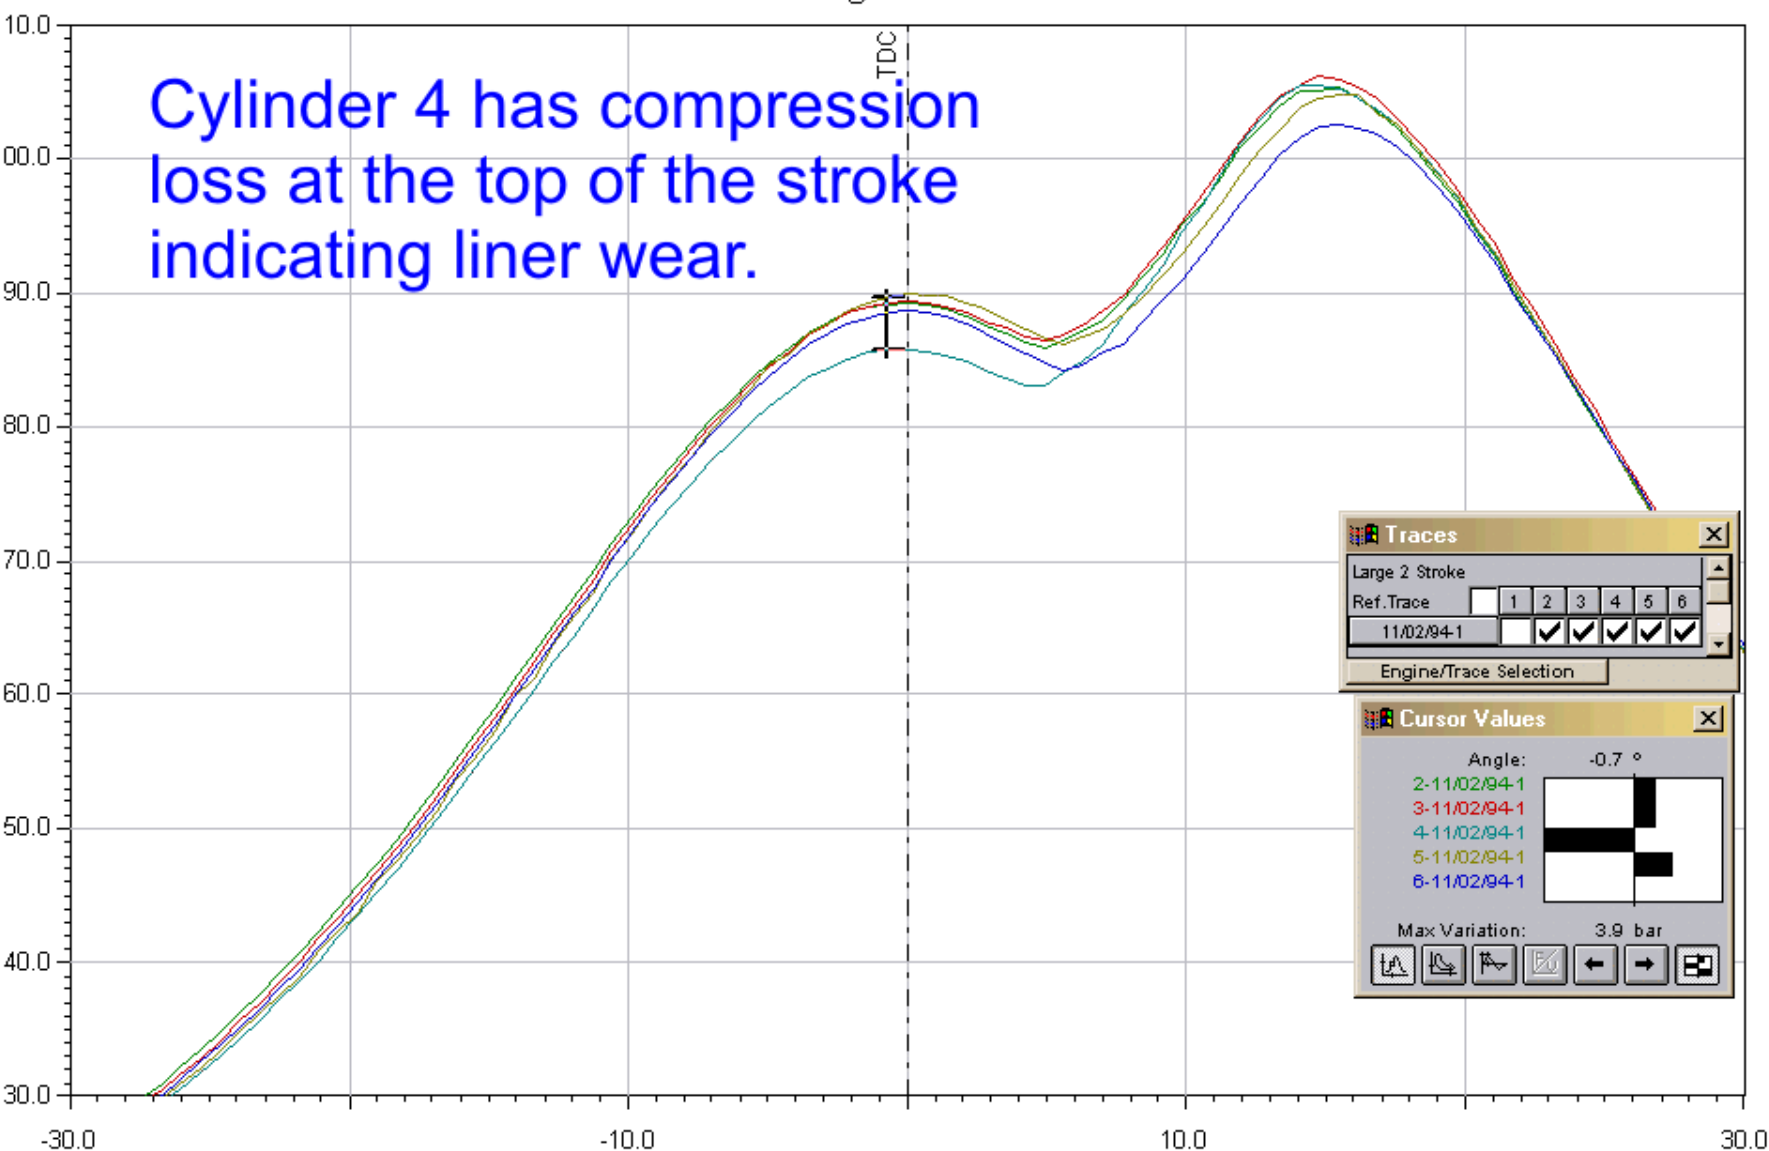
Cylinder 4 has compression loss at the top of the stroke indicating liner wear.

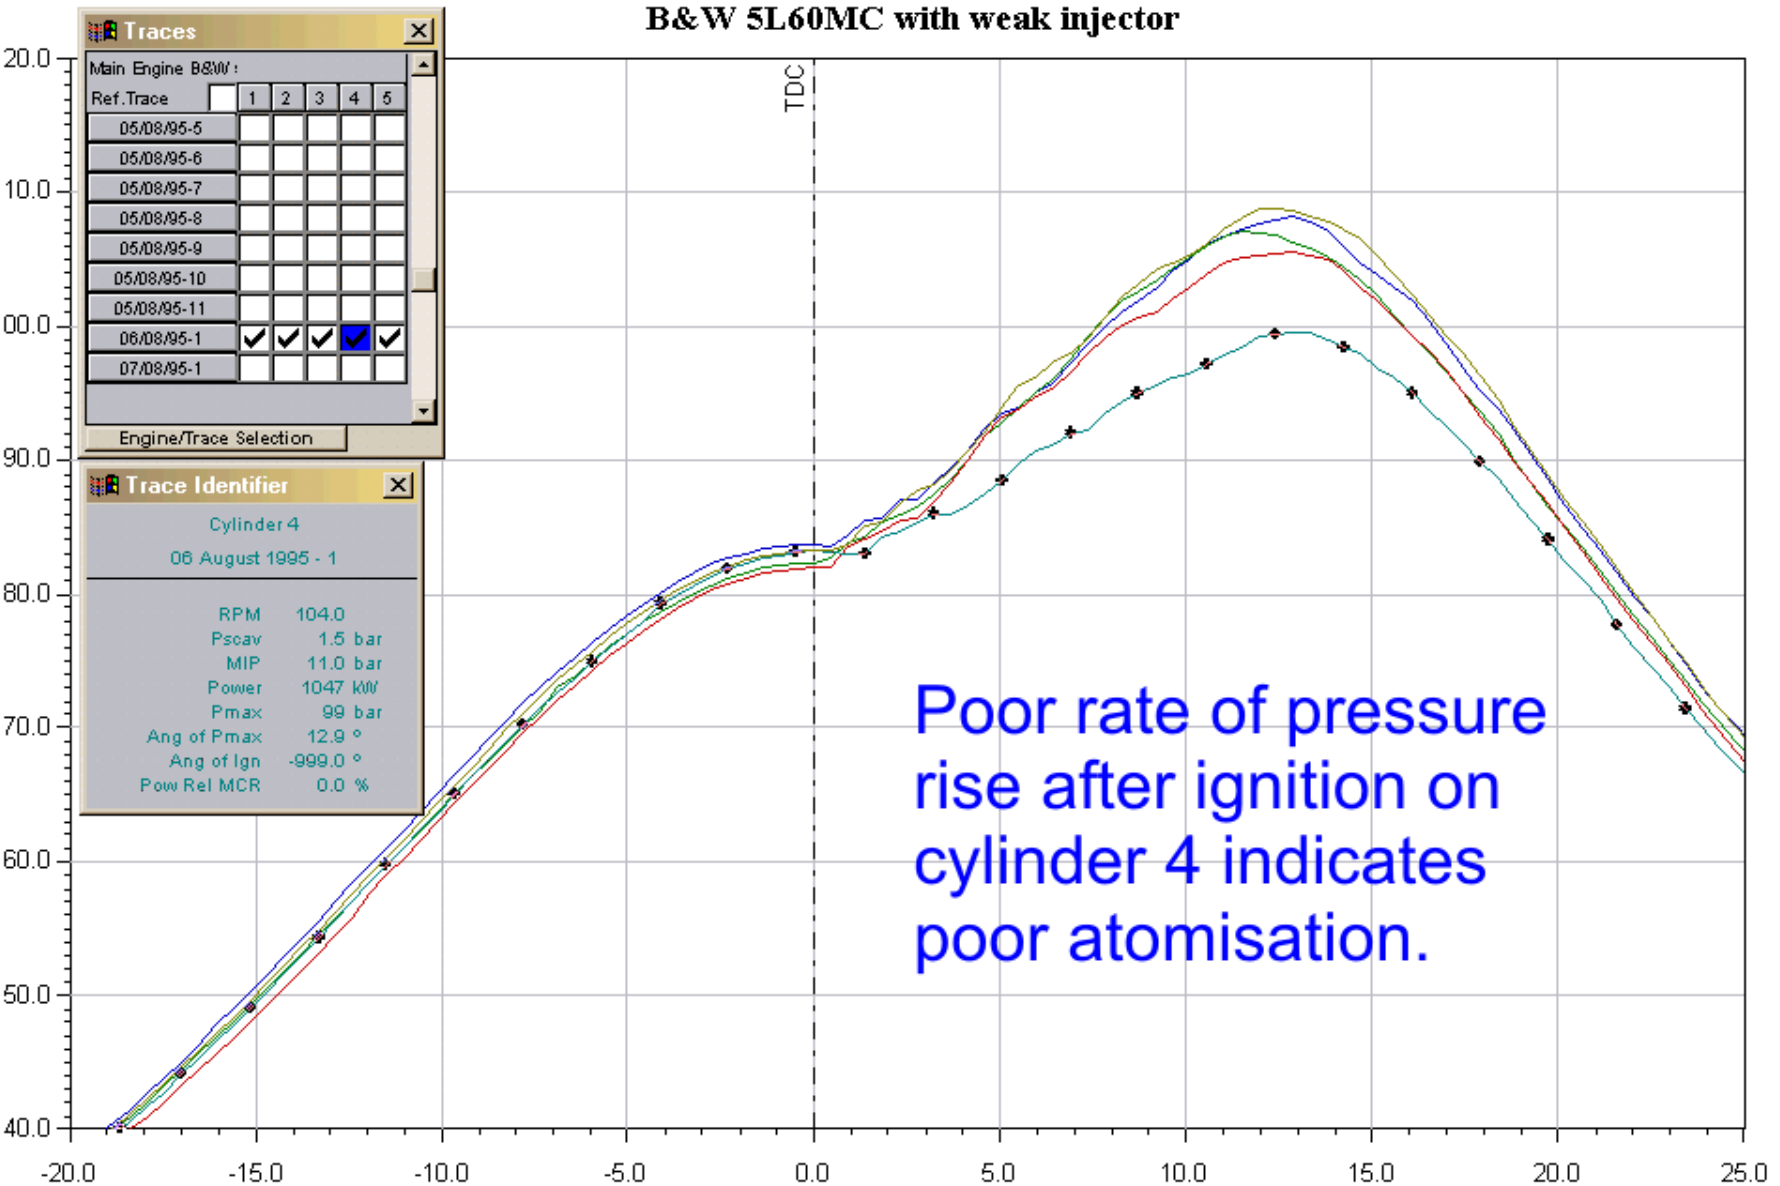
B&W 5L60MC with weak injector

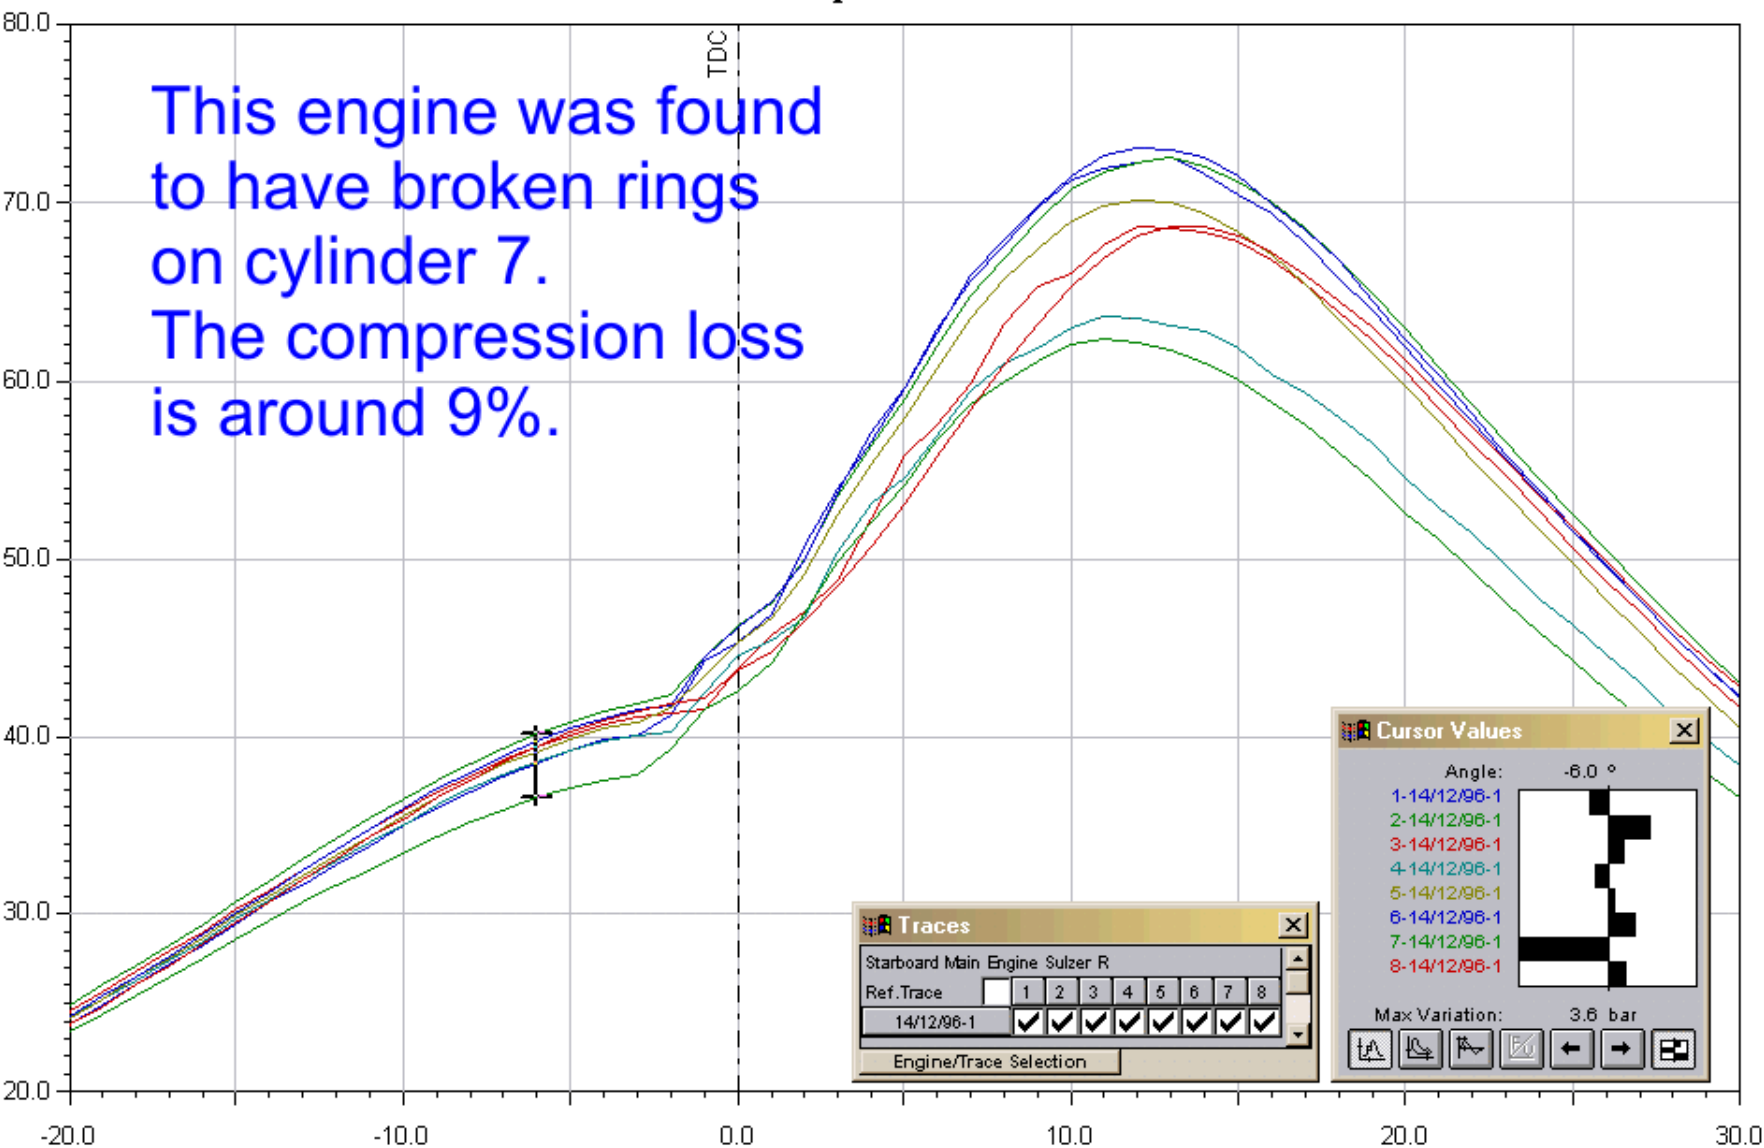
Compression Fault

This engine was found to have broken rings on cylinder 7. The compression loss is around 9%.

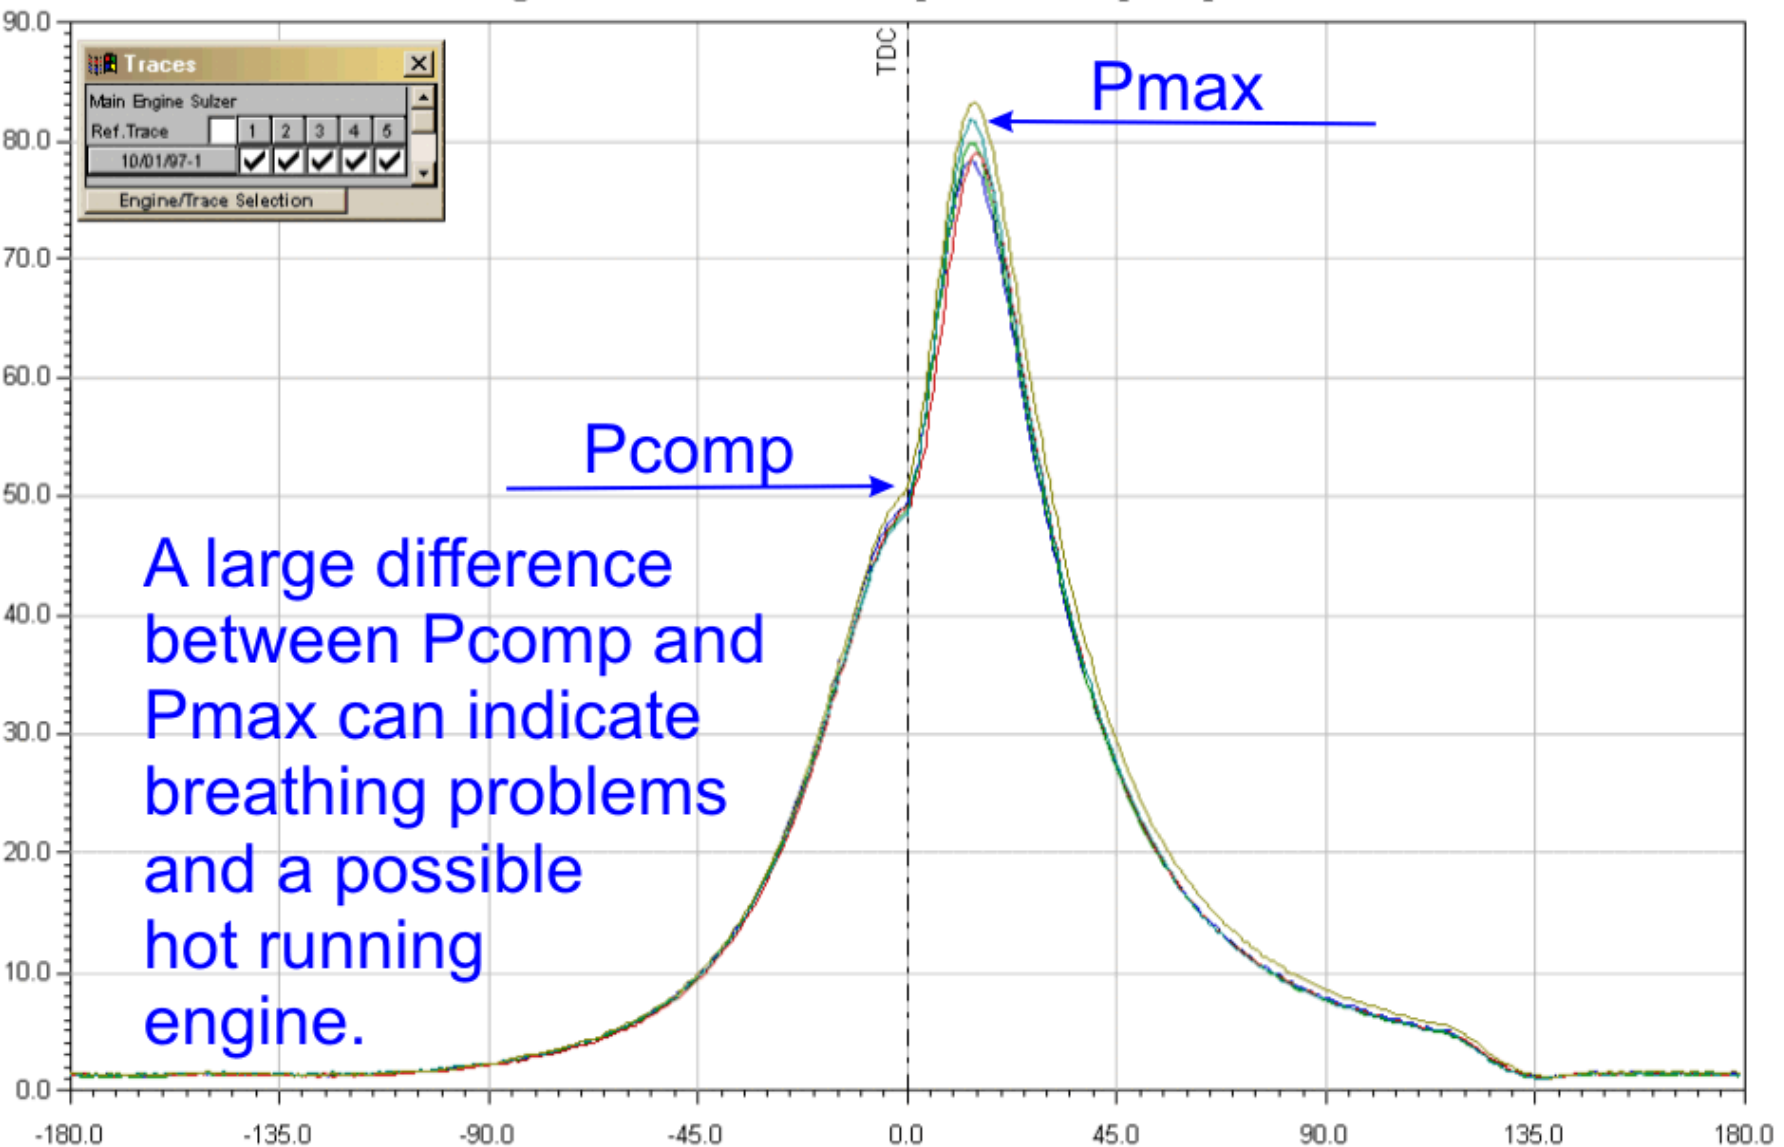
Large difference between compression and peak pressures.

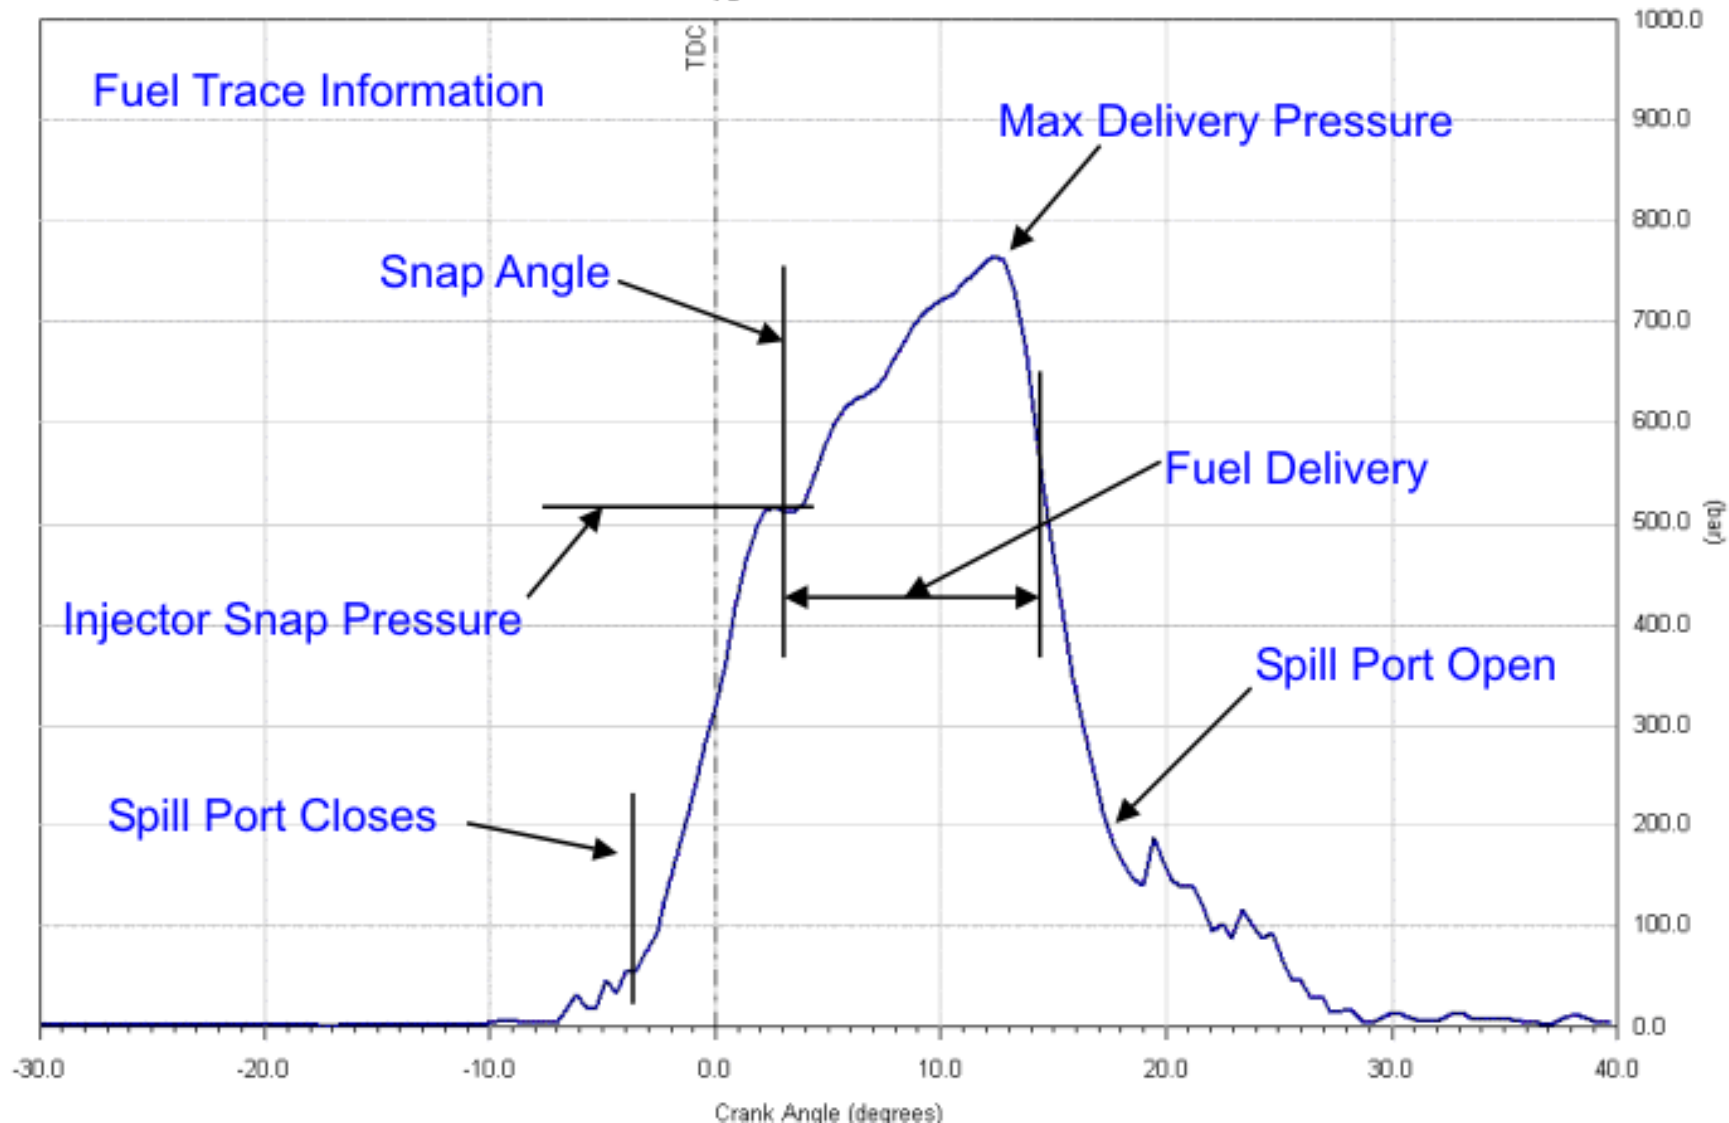
Typical Fuel Trace

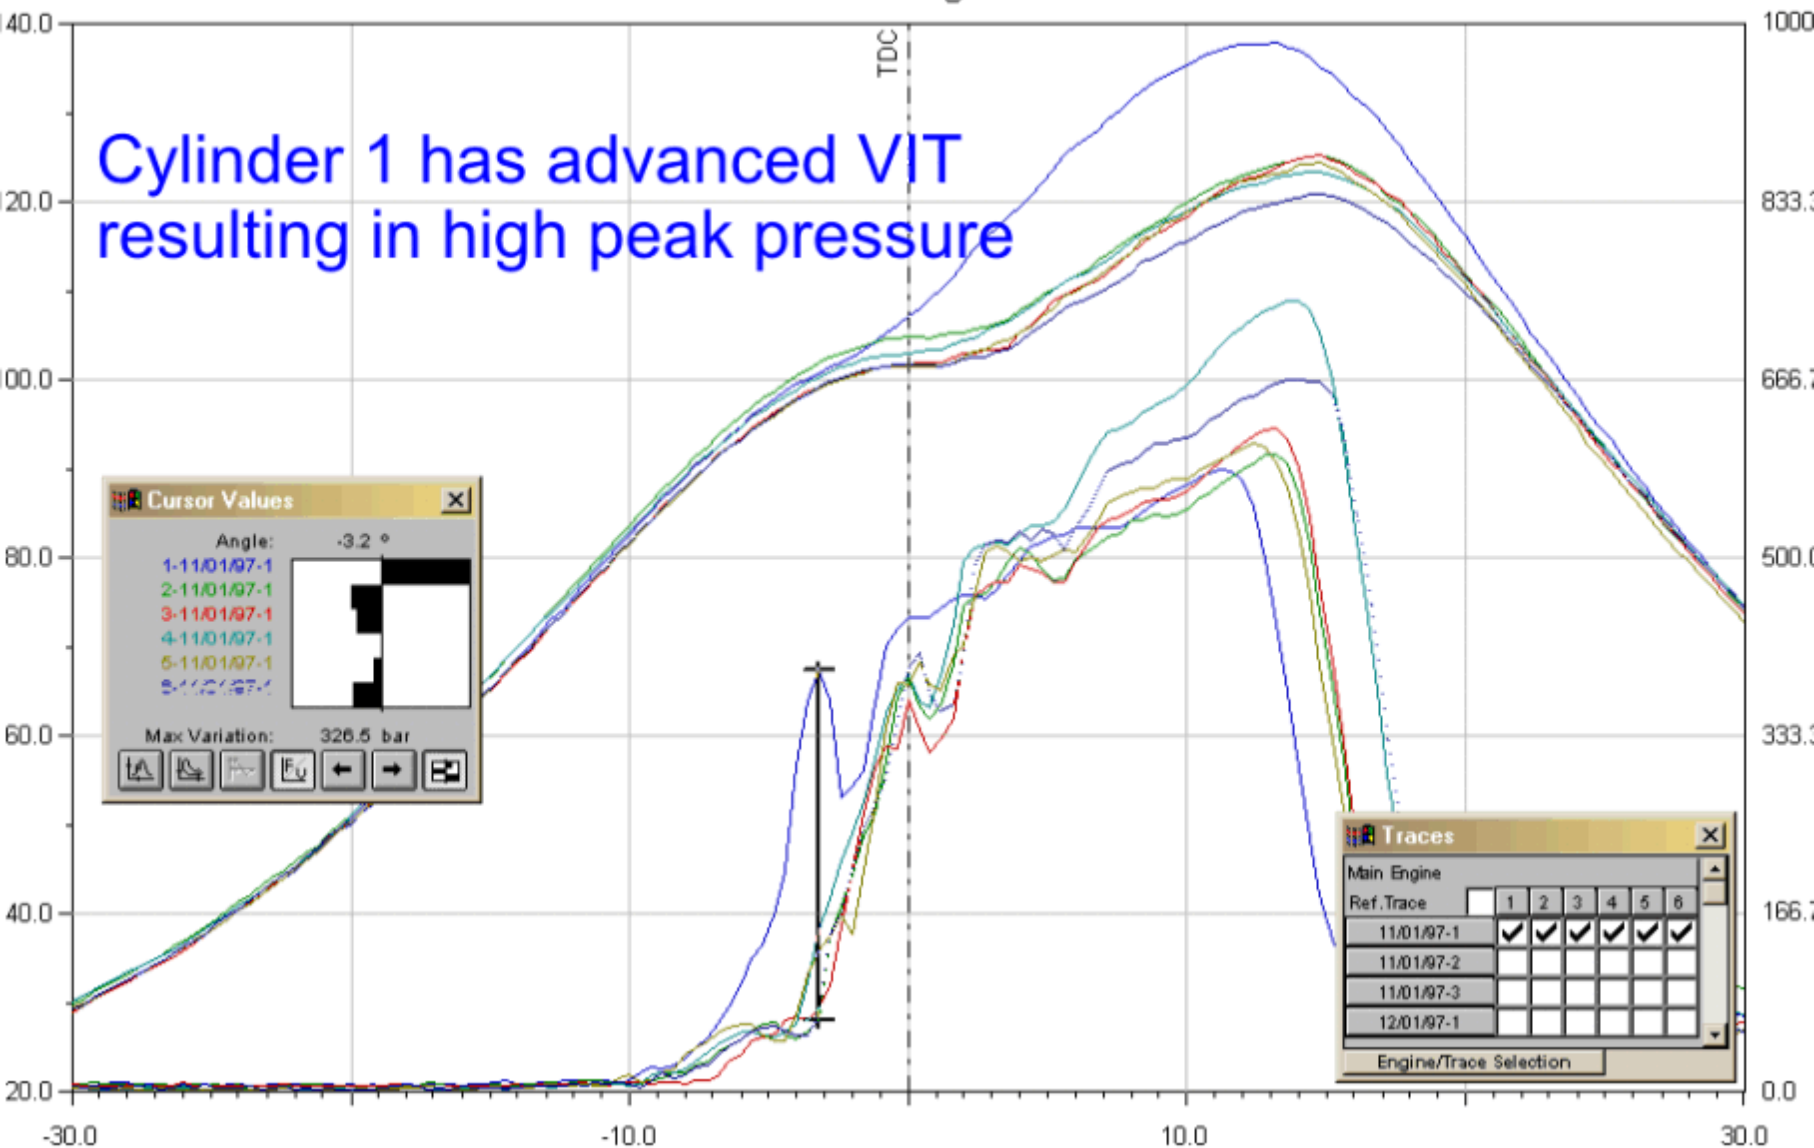
Cylinder 1 has advanced VIT
resulting in high peak pressure

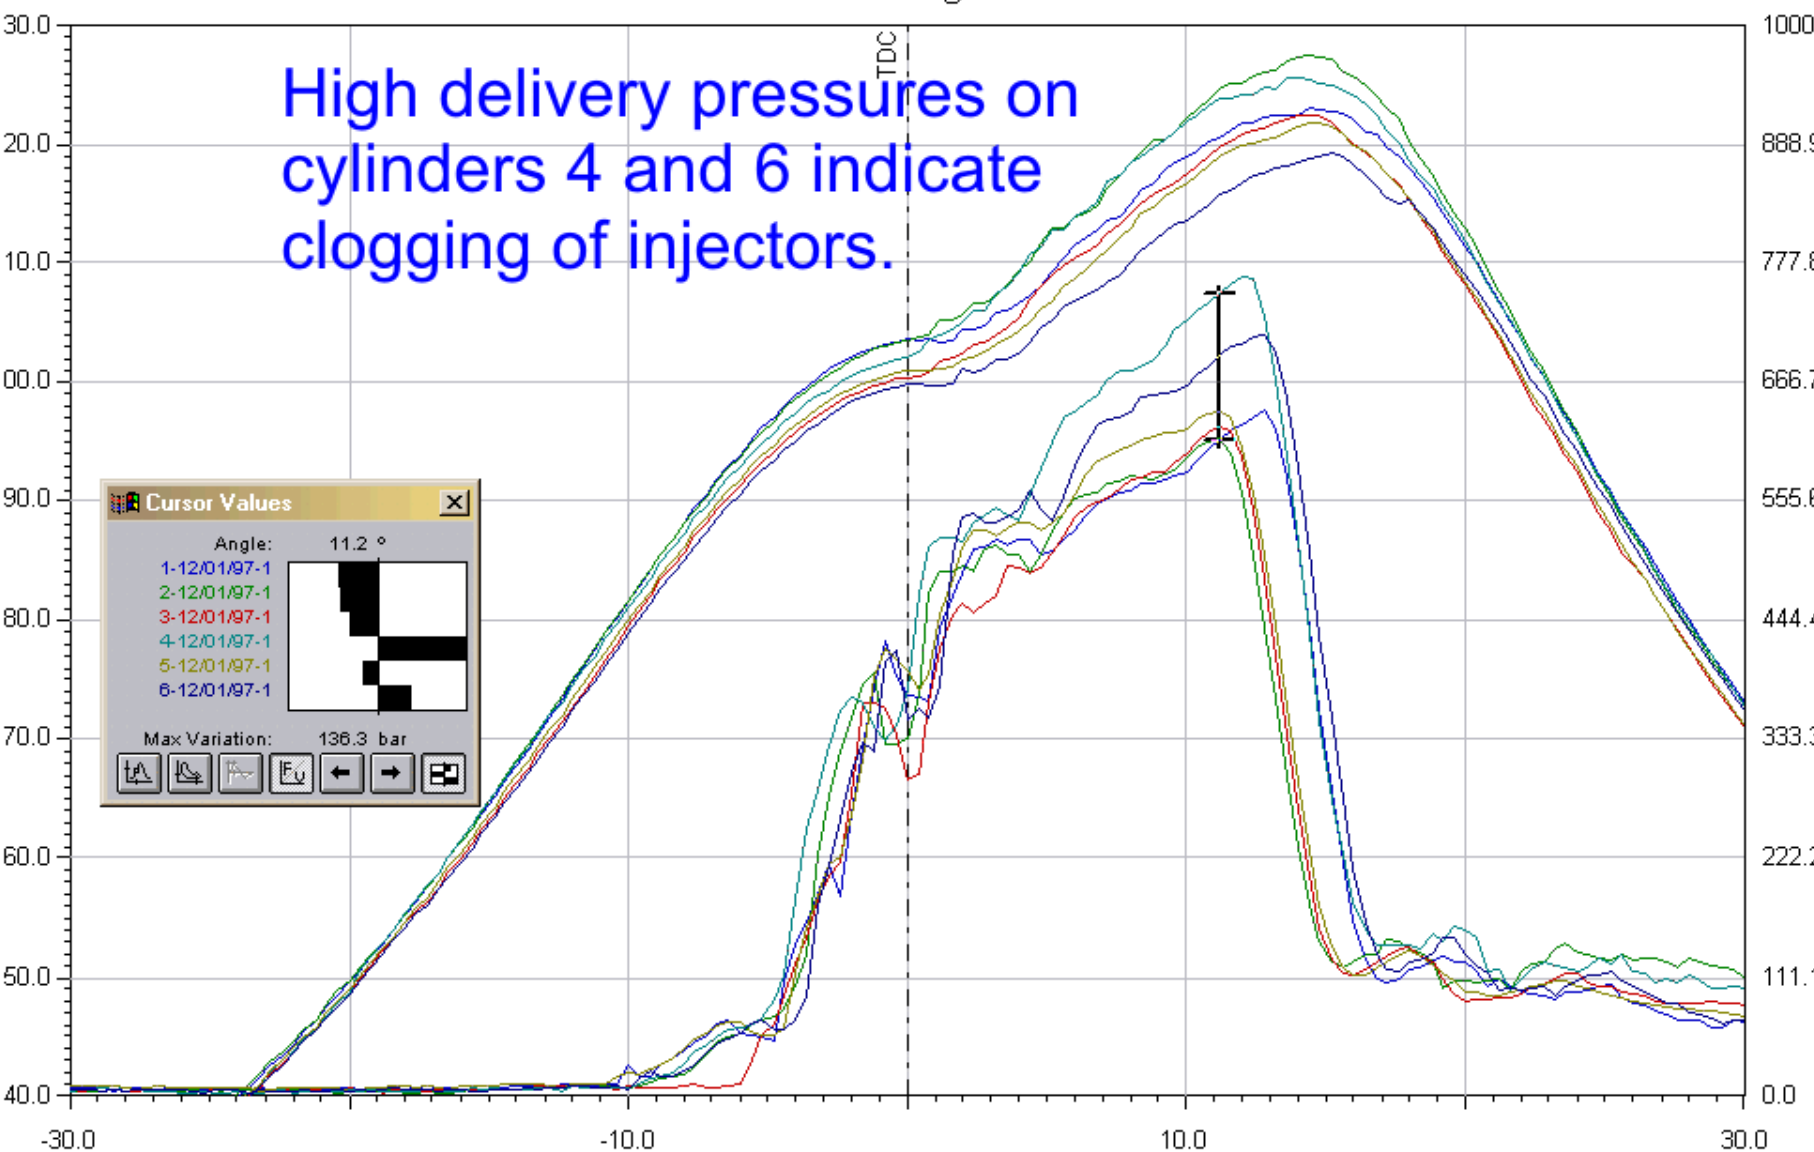
High delivery pressures on cylinders 4 and 6 indicate clogging of injectors.

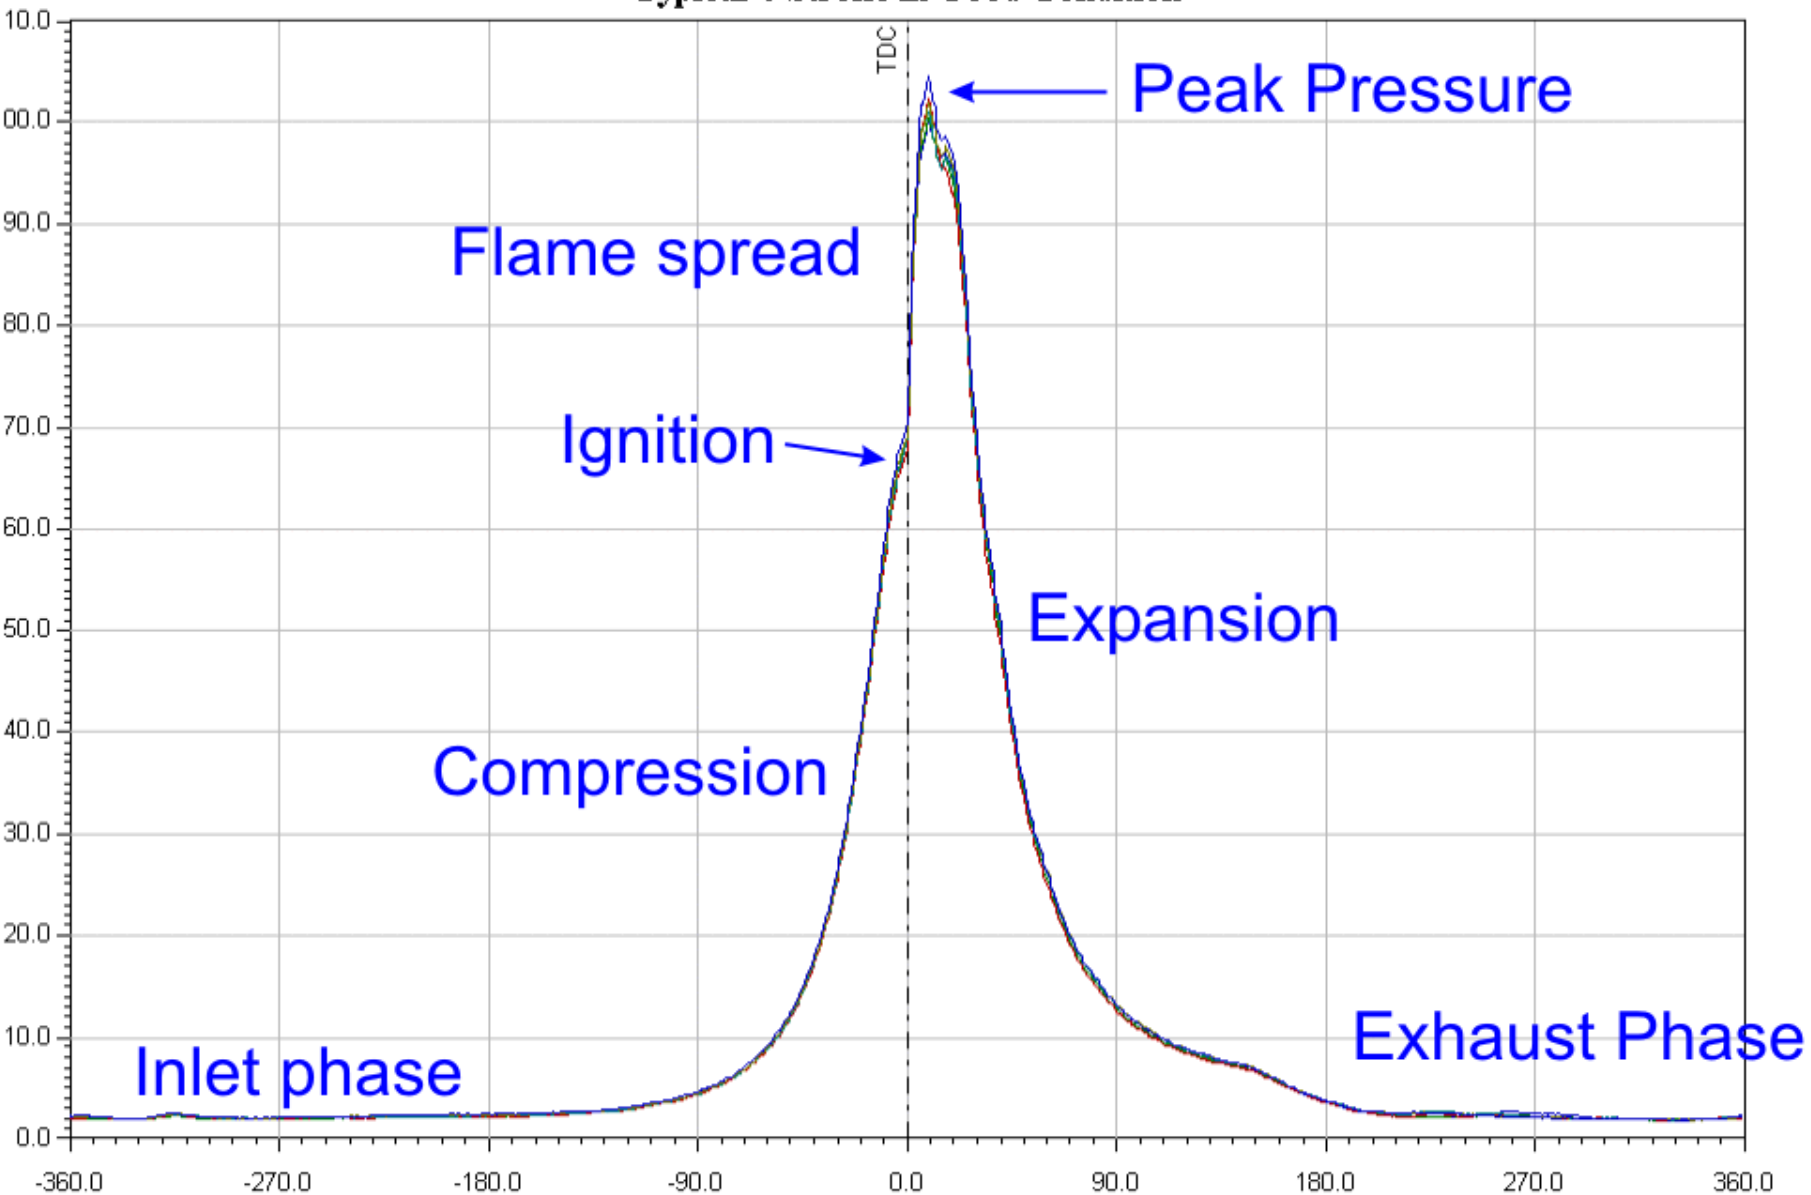
Typical 4-Stroke in Good Condition

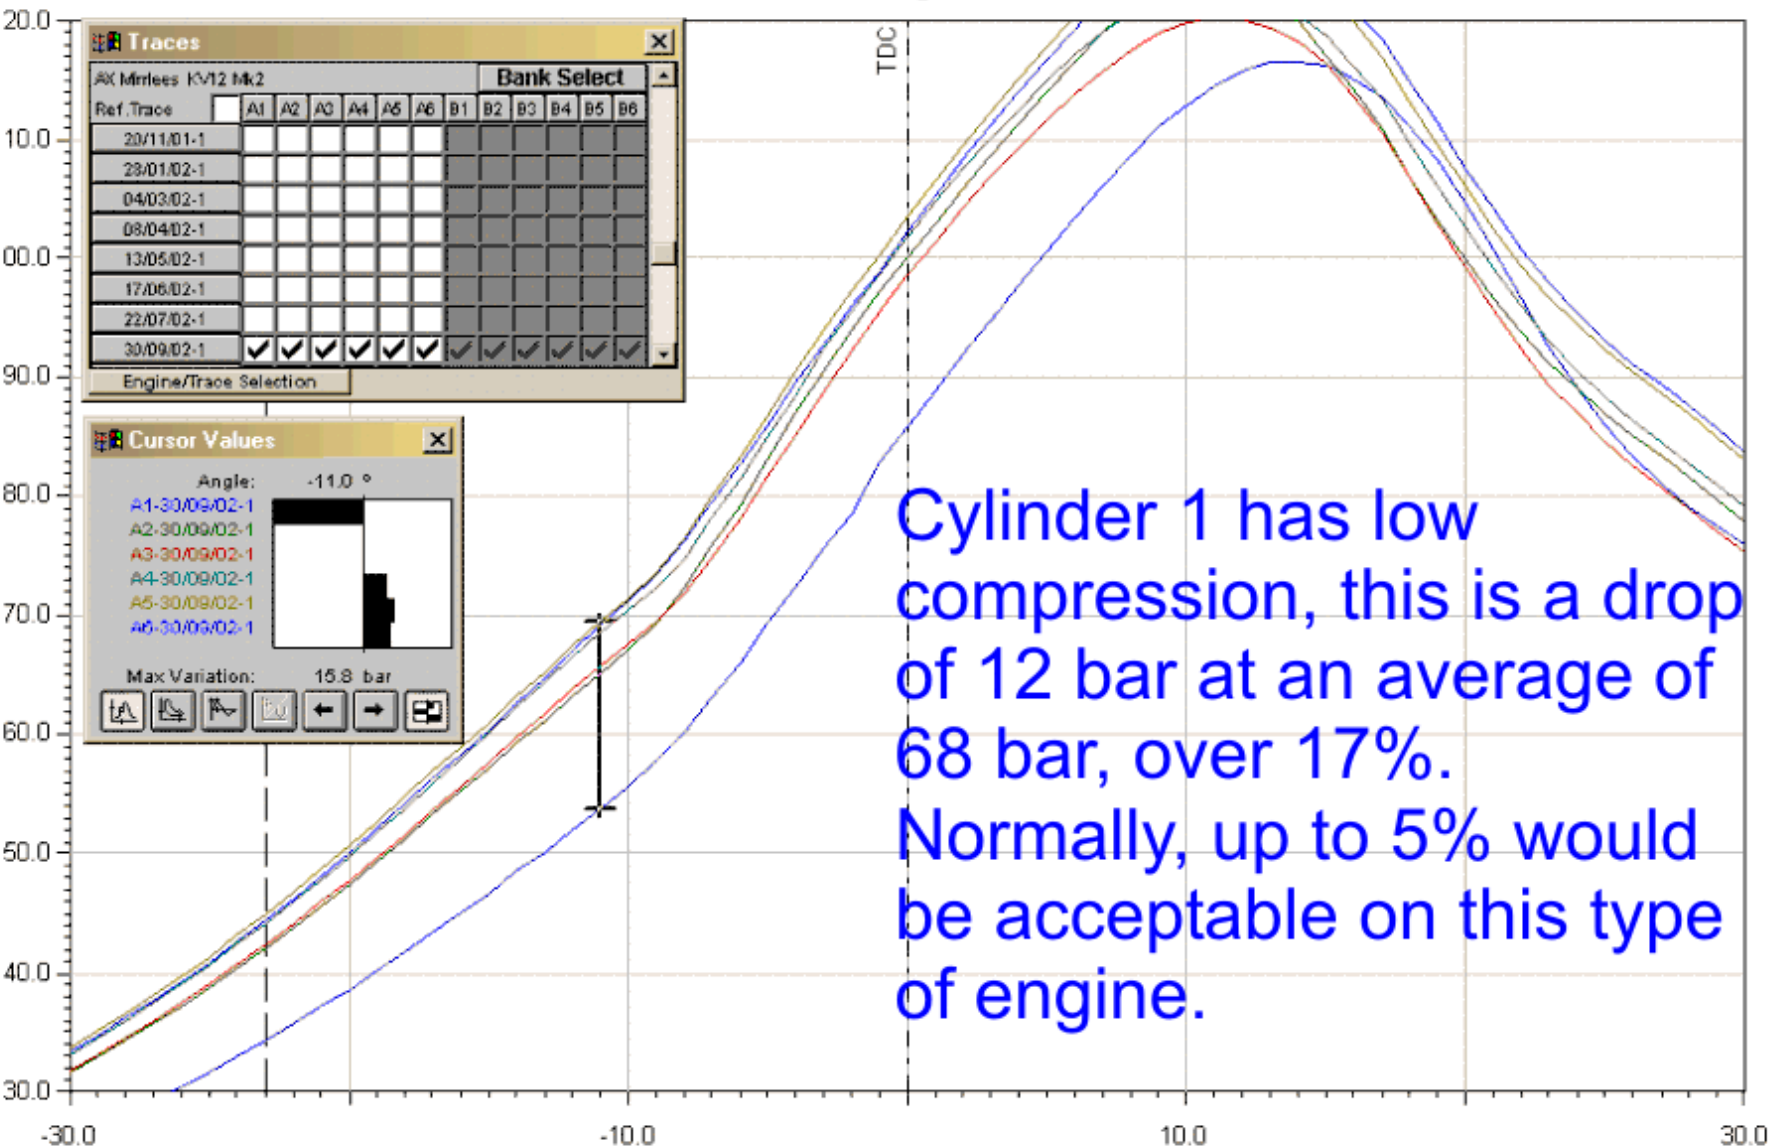
Low Compression

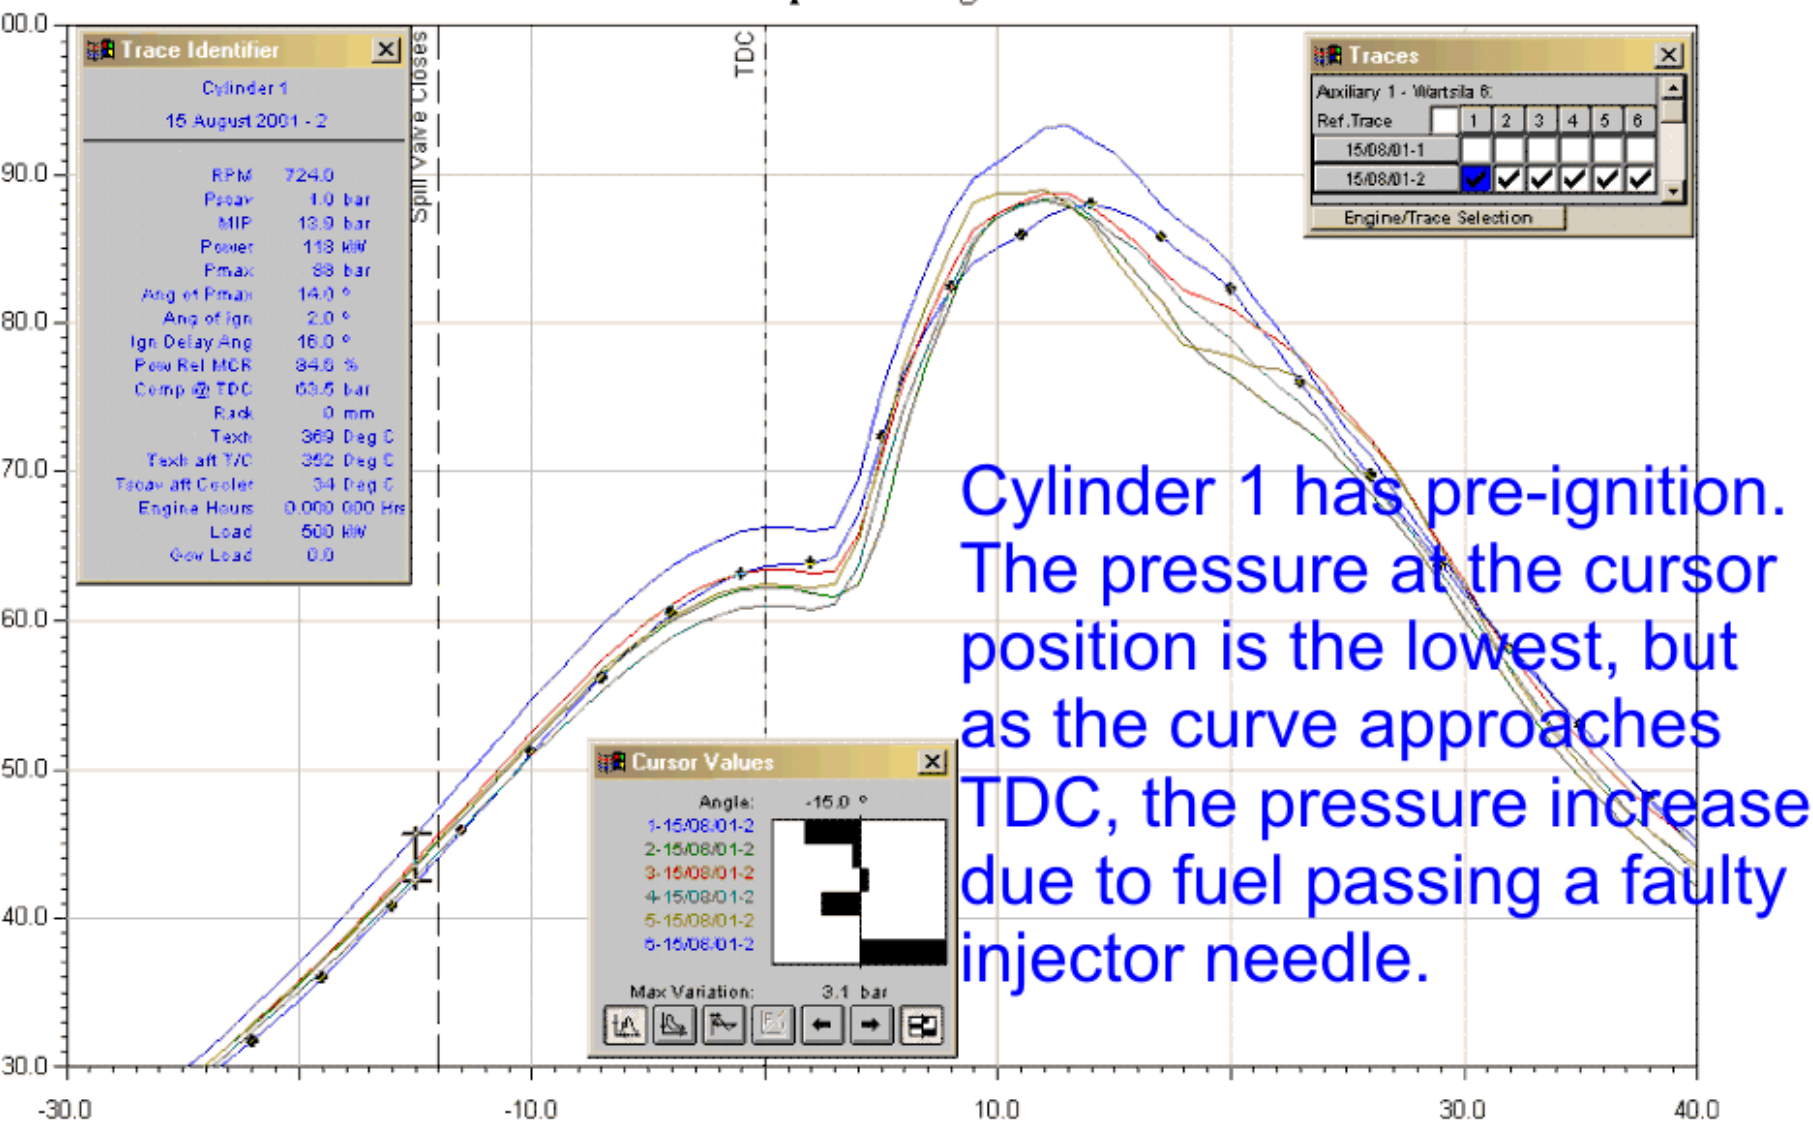
Example of Pre-Ignition

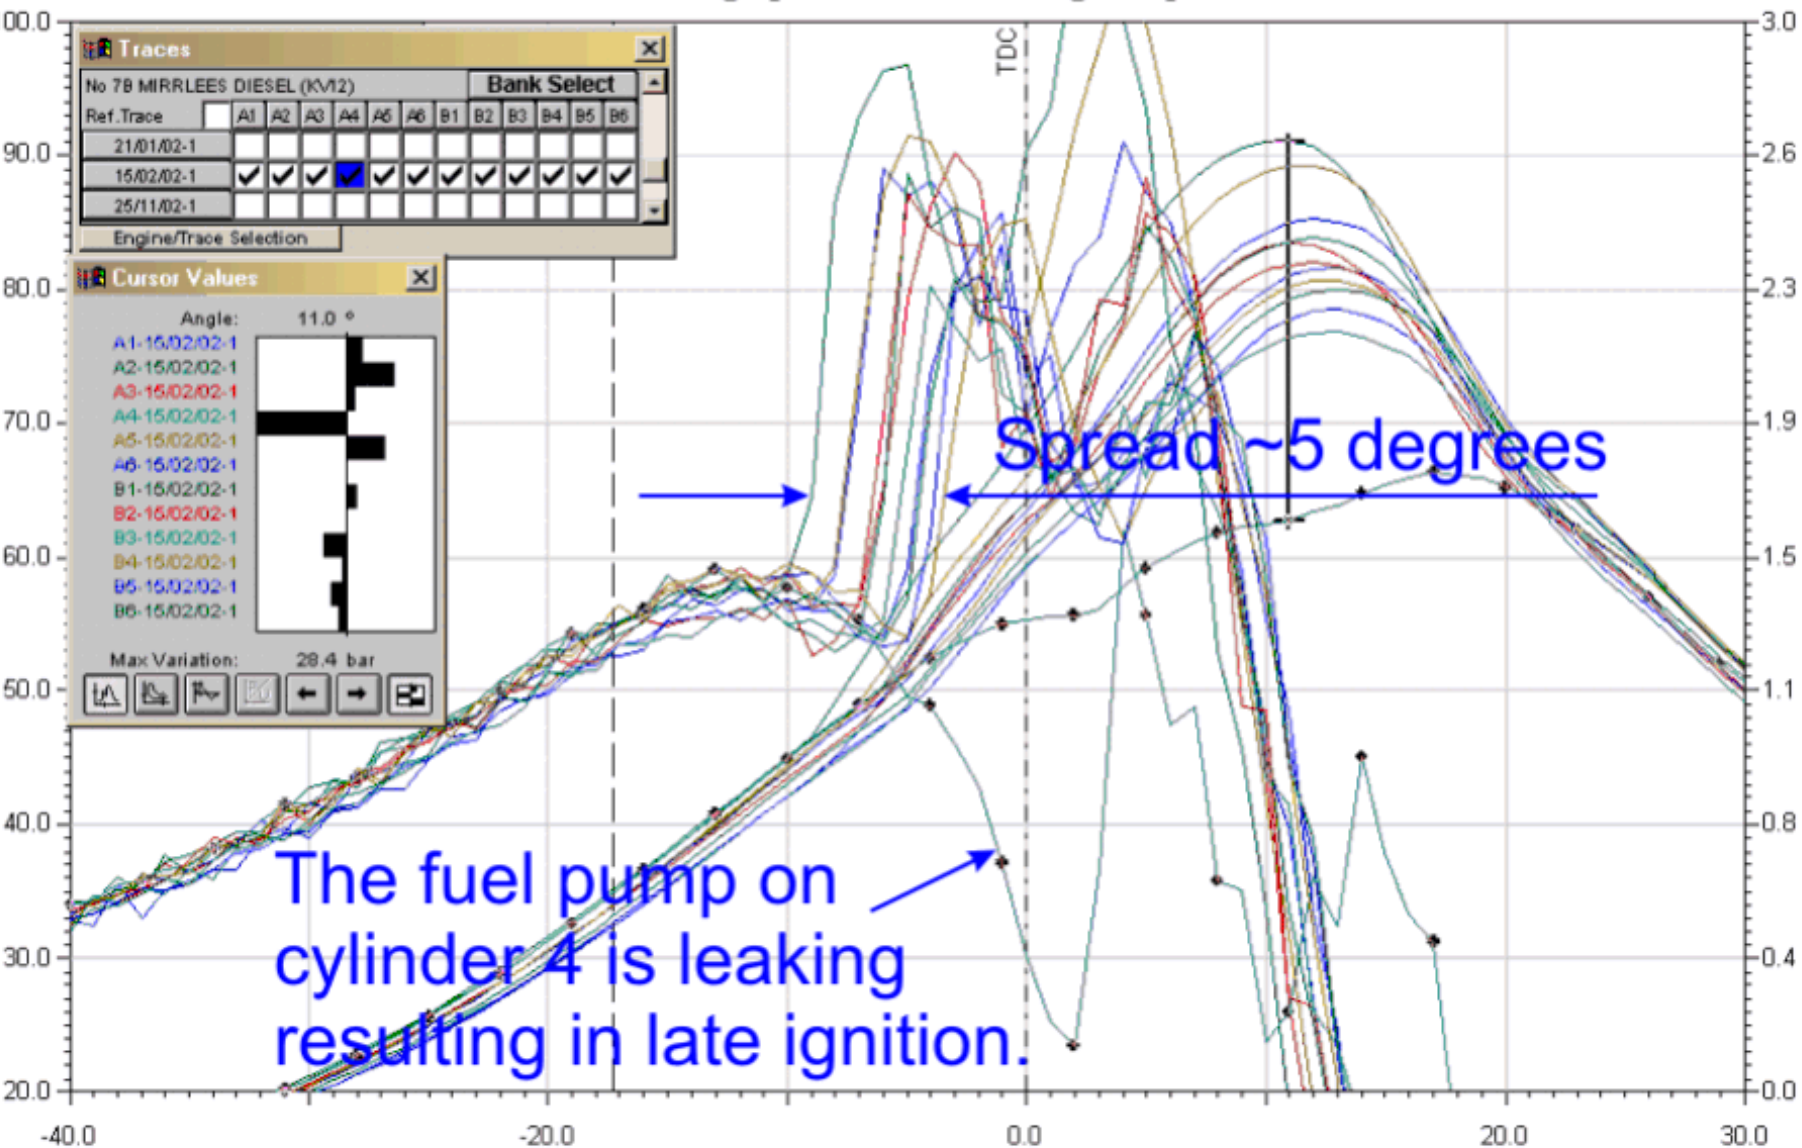
Timing Spread and a Leaking Pump
