Basic Analysis Tools

2-Stroke Analysis

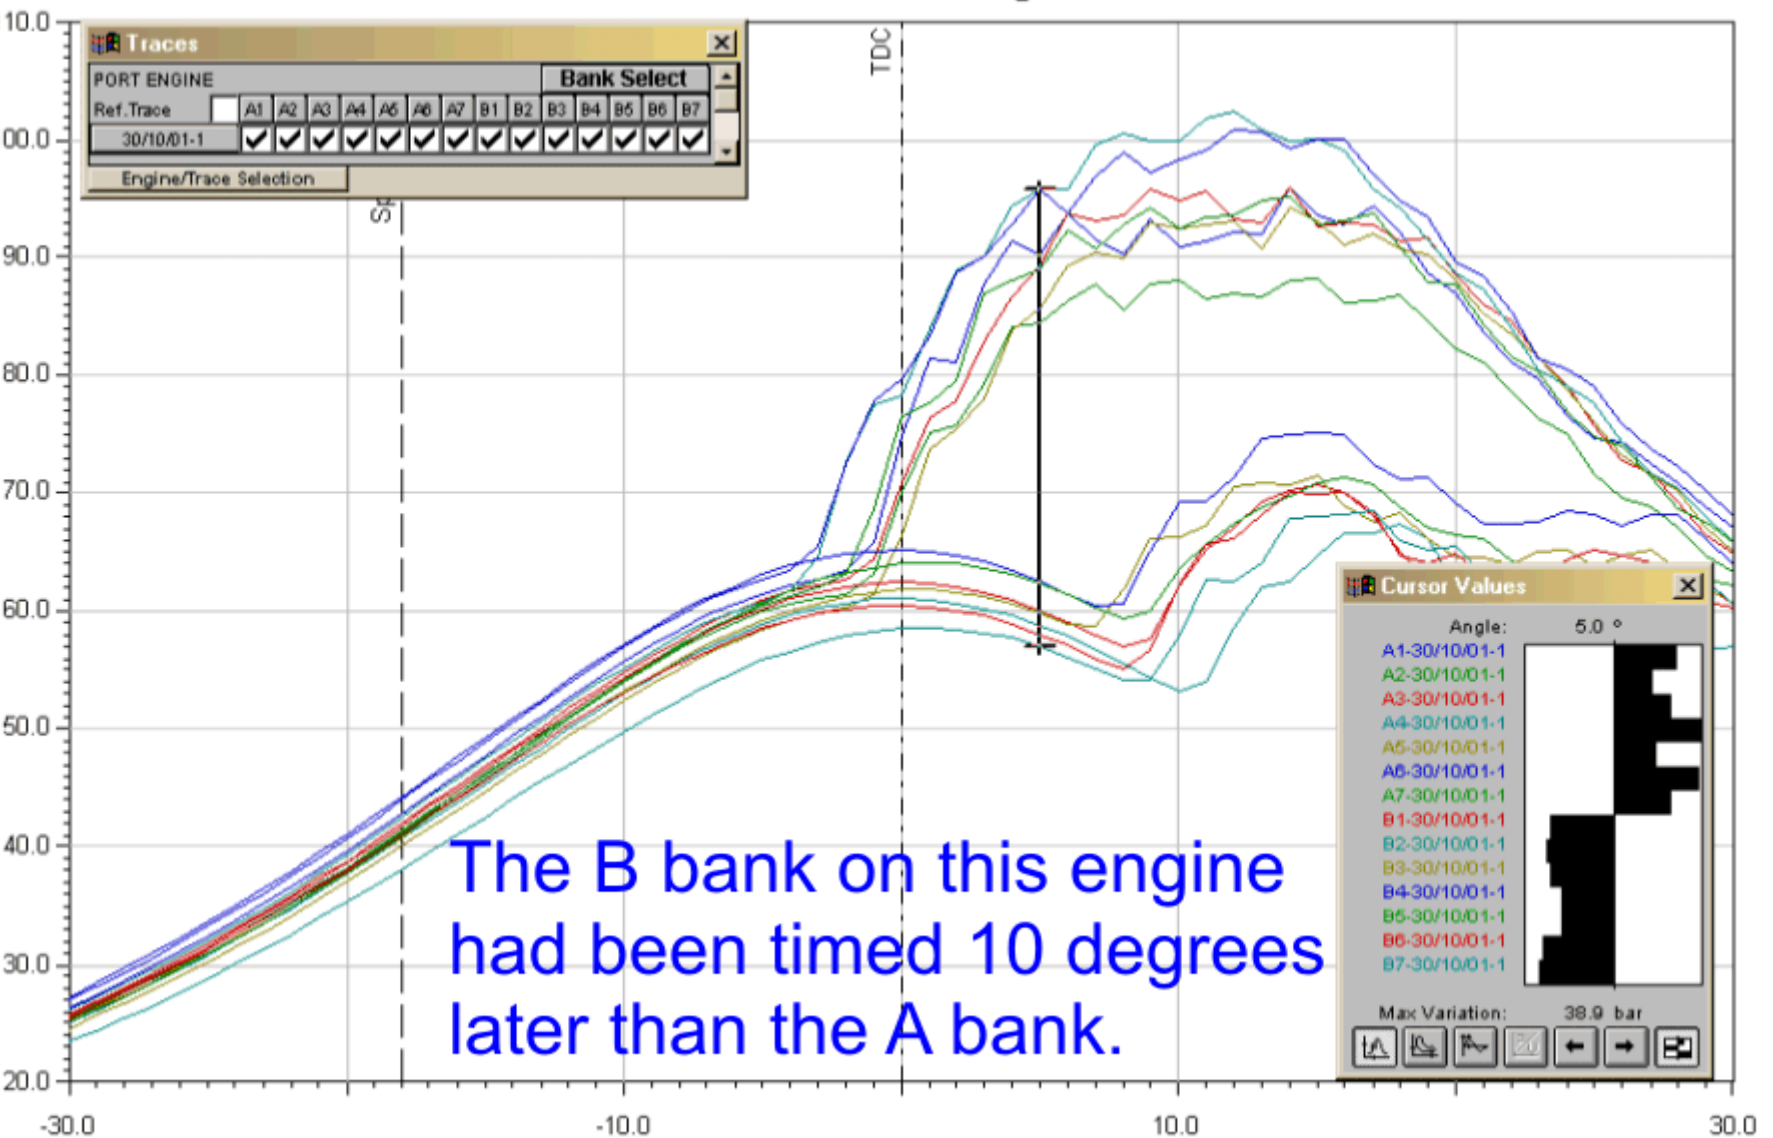
Incorrect Timing

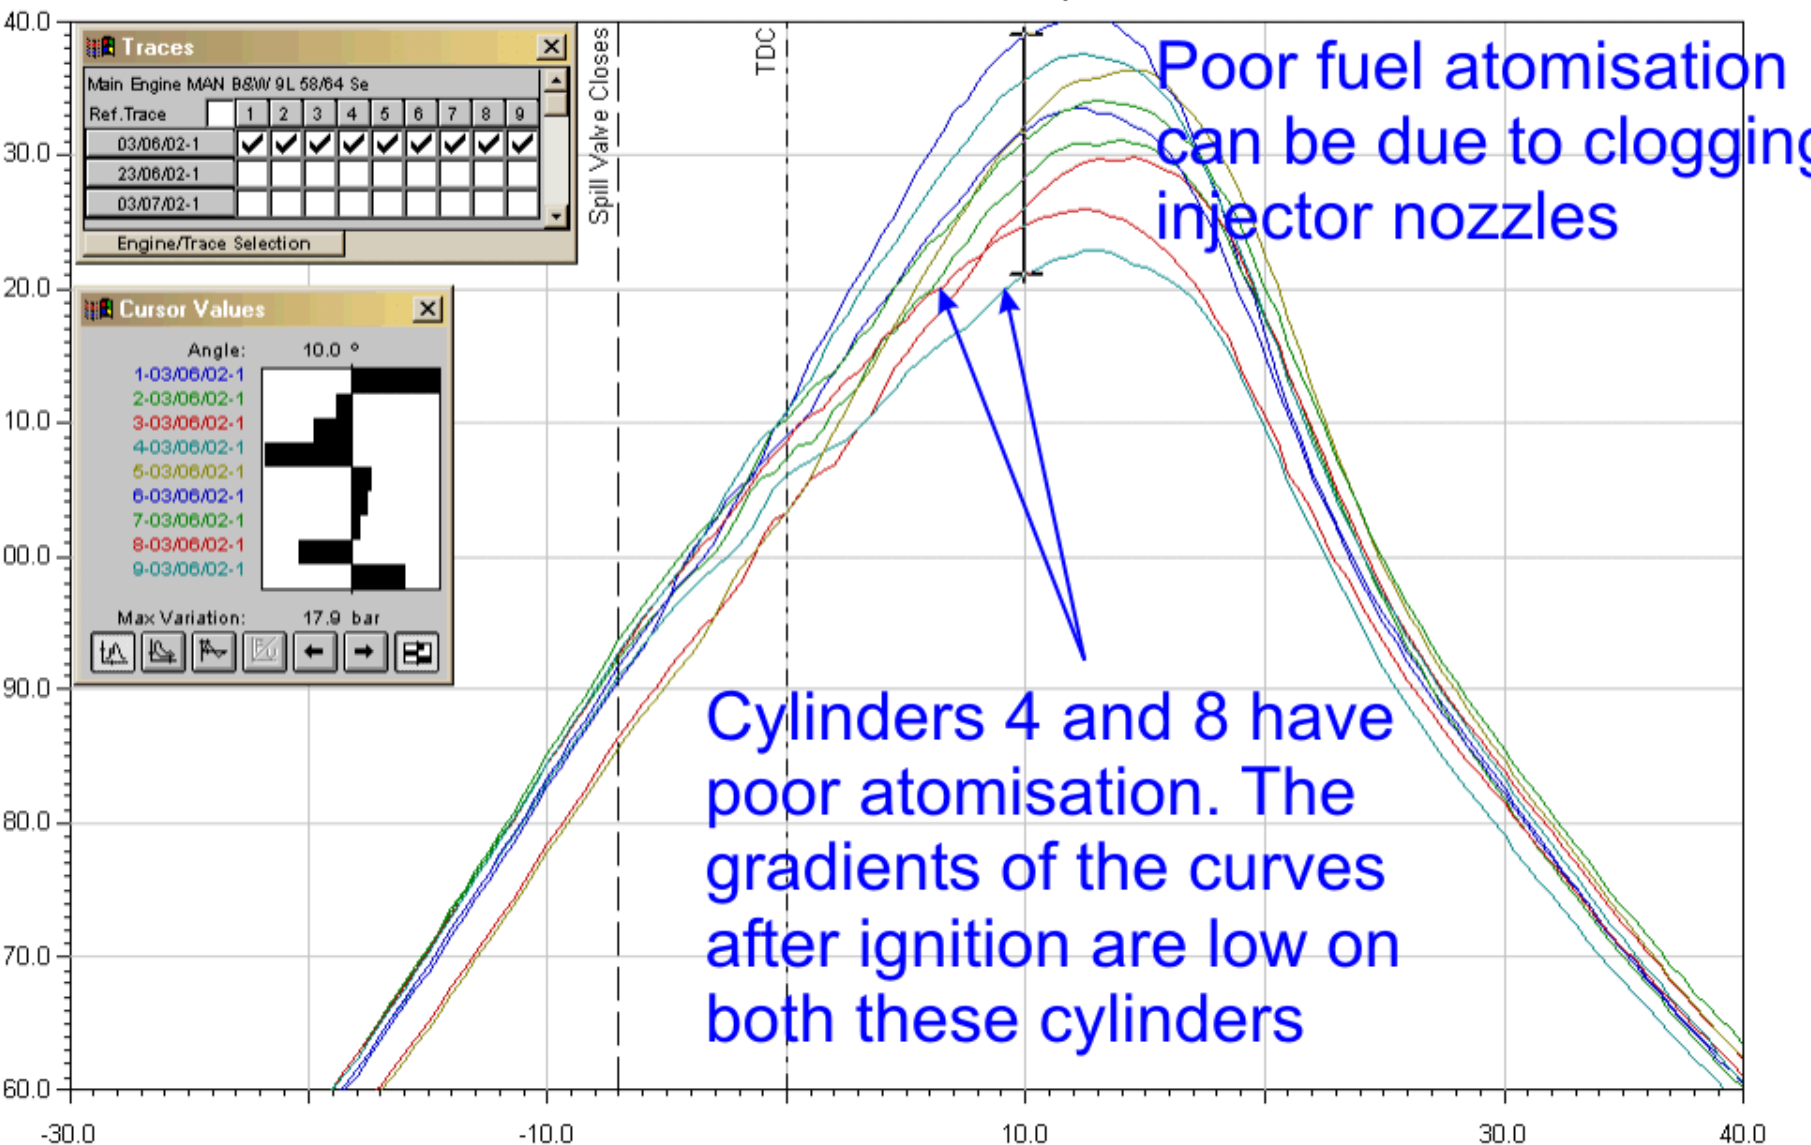
Poor Atomisation on Two Cylinders

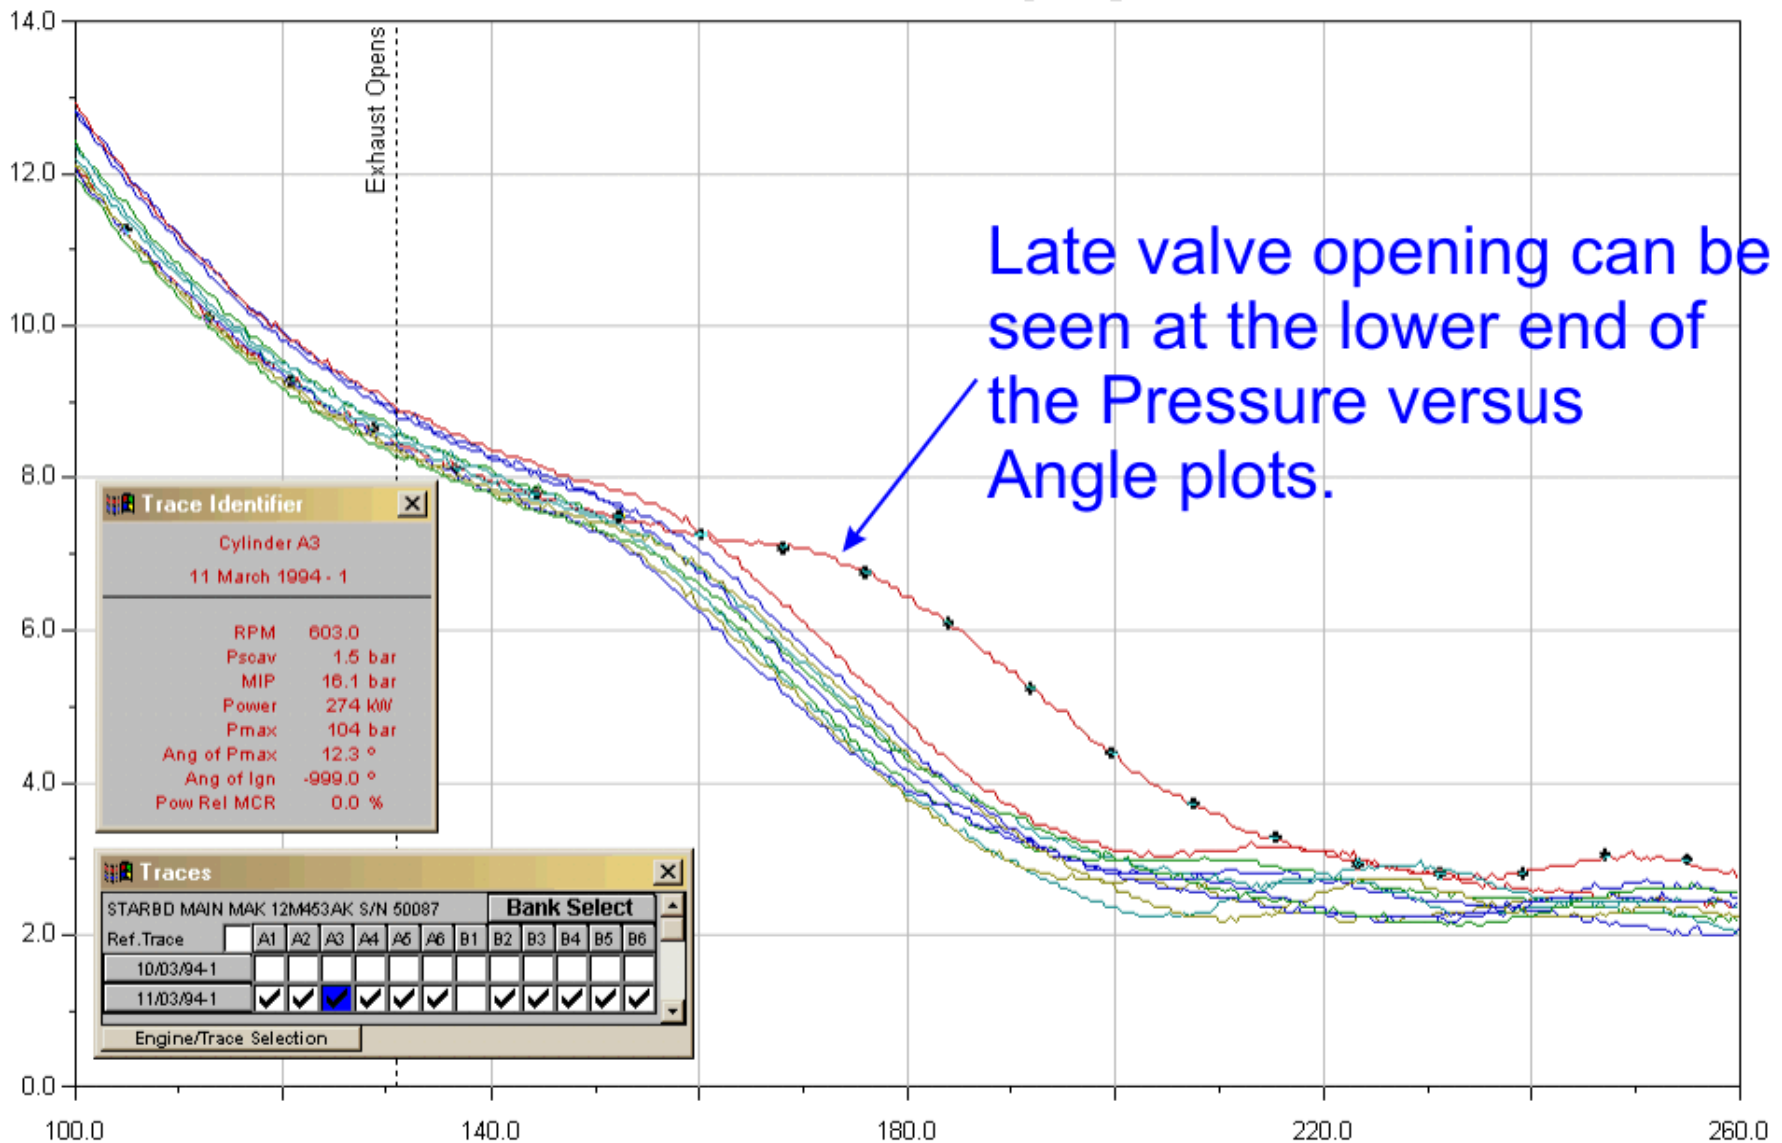
Late Exhaust Valve Opening

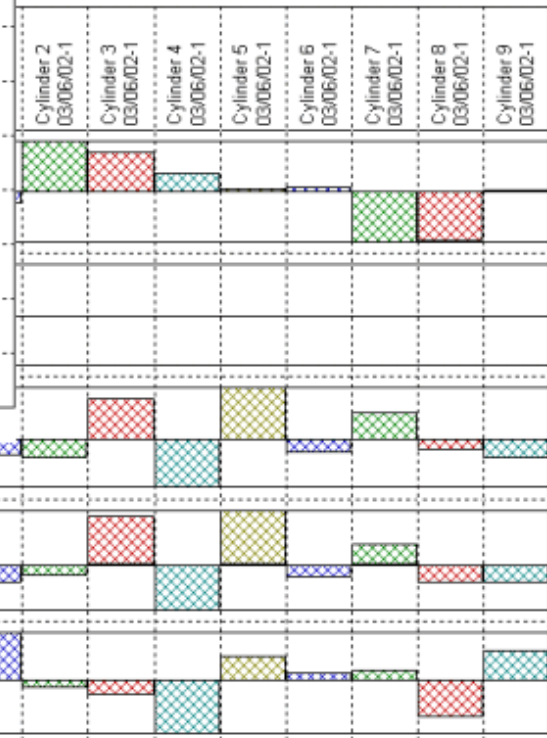
Power Results

13.5 % variation is more than desirable. Under 10% would be OK

Tables show totals and variations, bar graphs give instant visual comparison

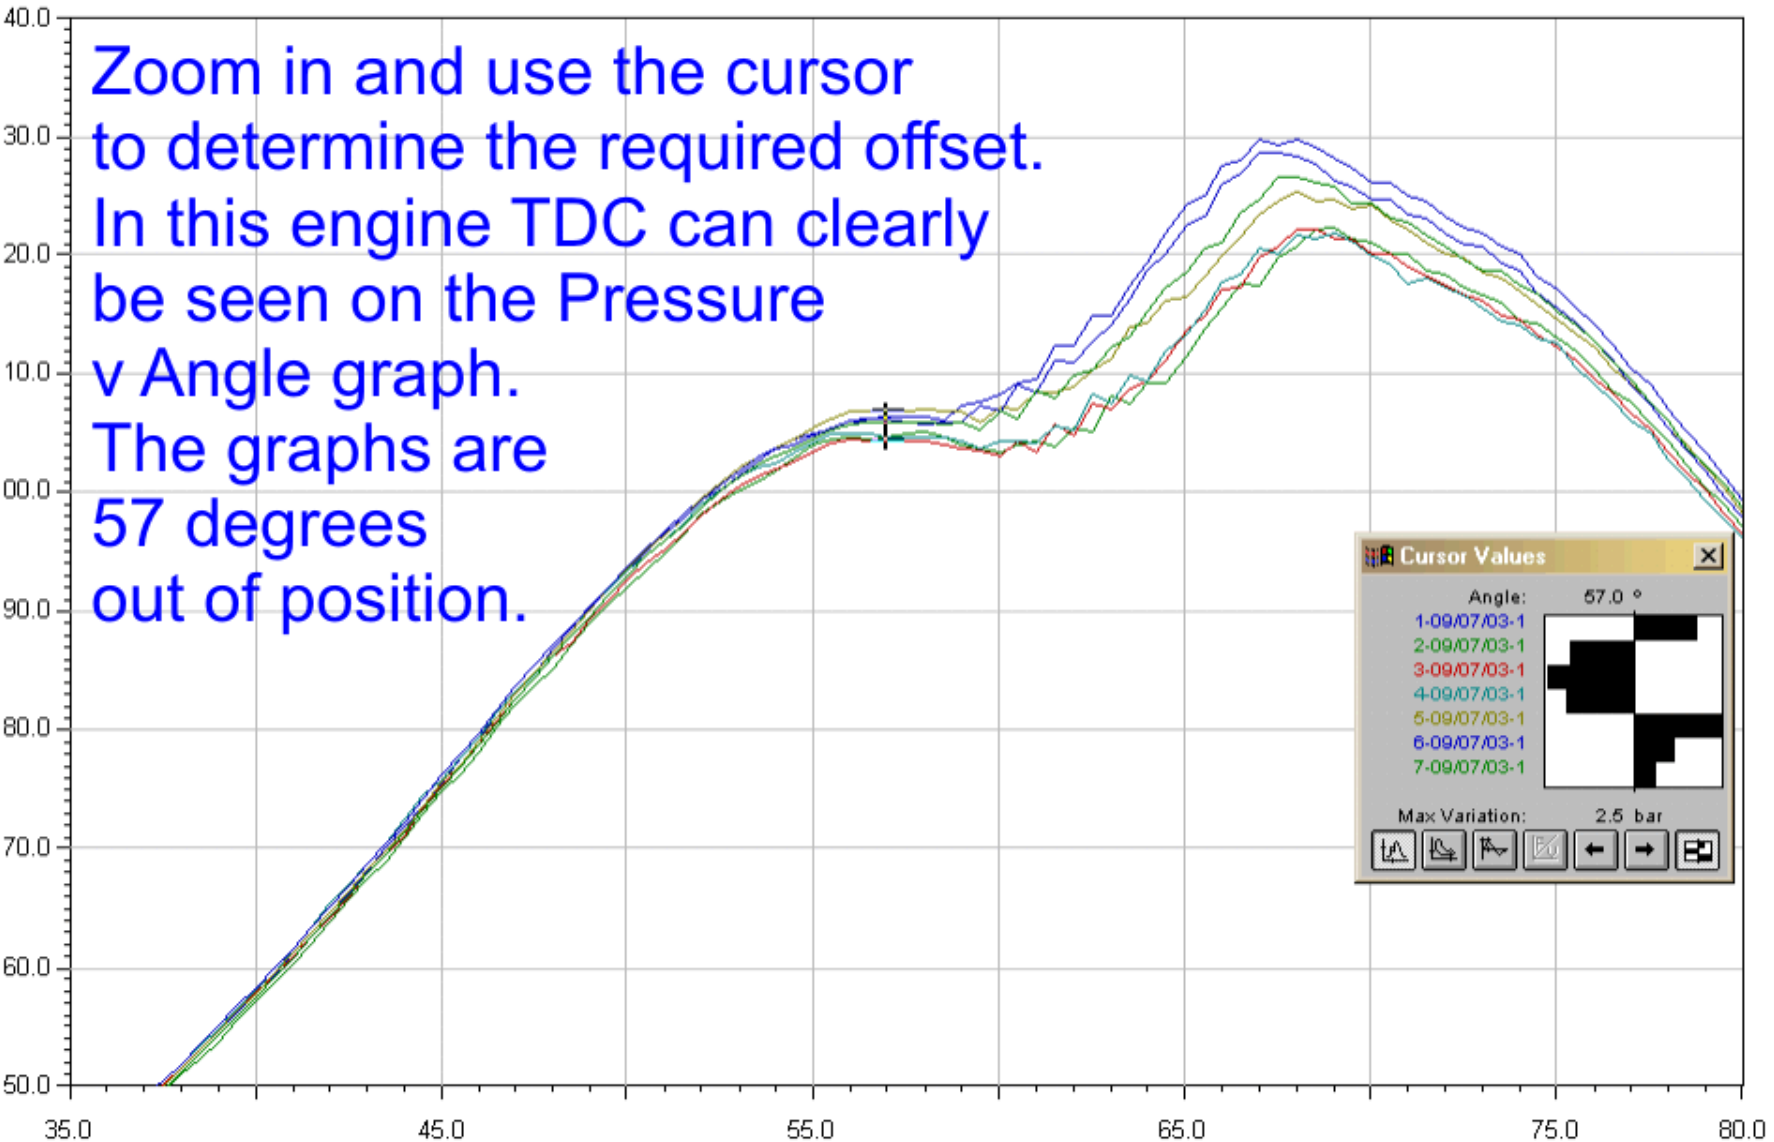
Offset Graphs Due to Incorrect TDC Offset

Zoom in and use the cursor
to determine the required offset.
In this engine TDC can clearly
be seen on the Pressure
v Angle graph.
The graphs are
57 degrees
out of position.

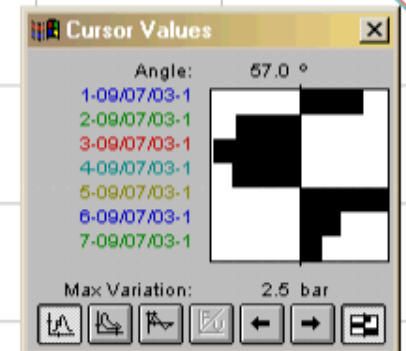
The offset to enter is -57 degrees for all cylinders to correct the 57 degree error. All cylinders normally have the same offset applied.

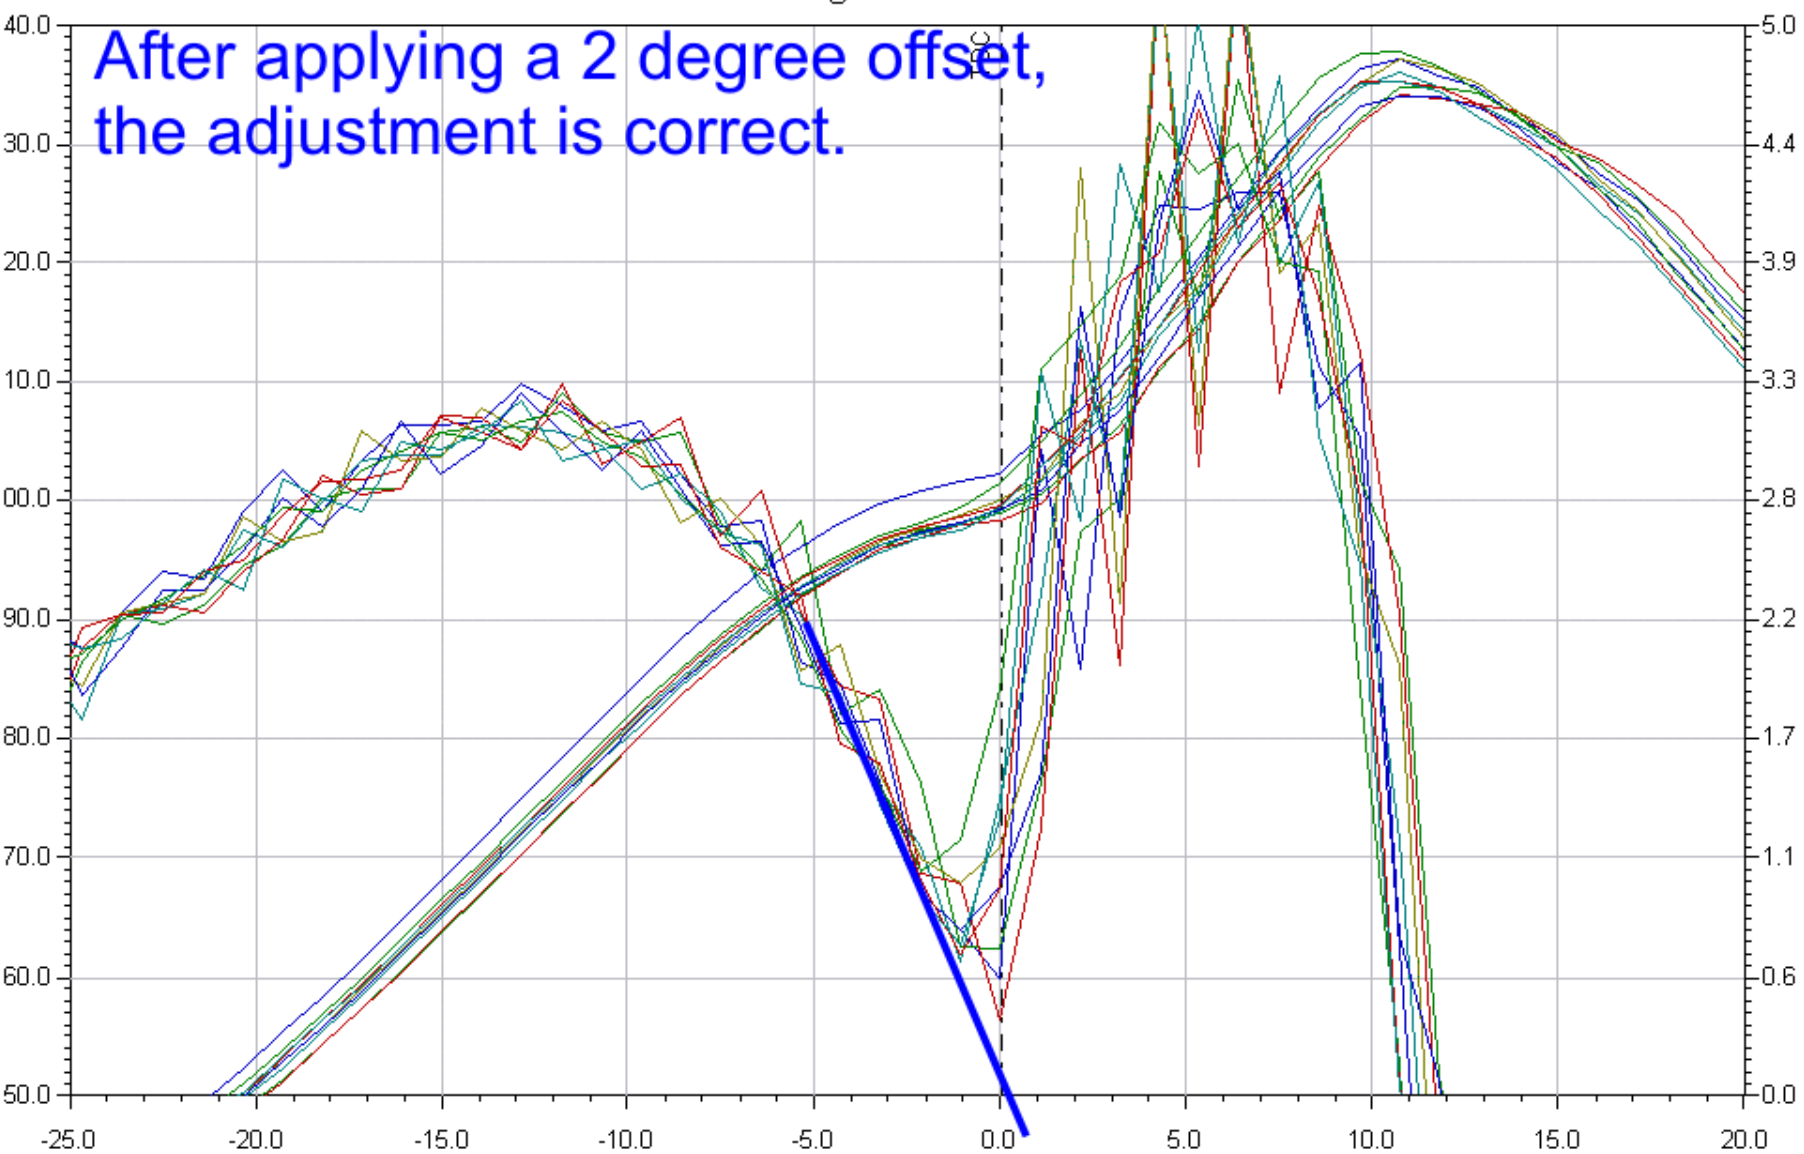
Firing Prior to TDC

After applying a 2 degree offset,
the adjustment is correct.

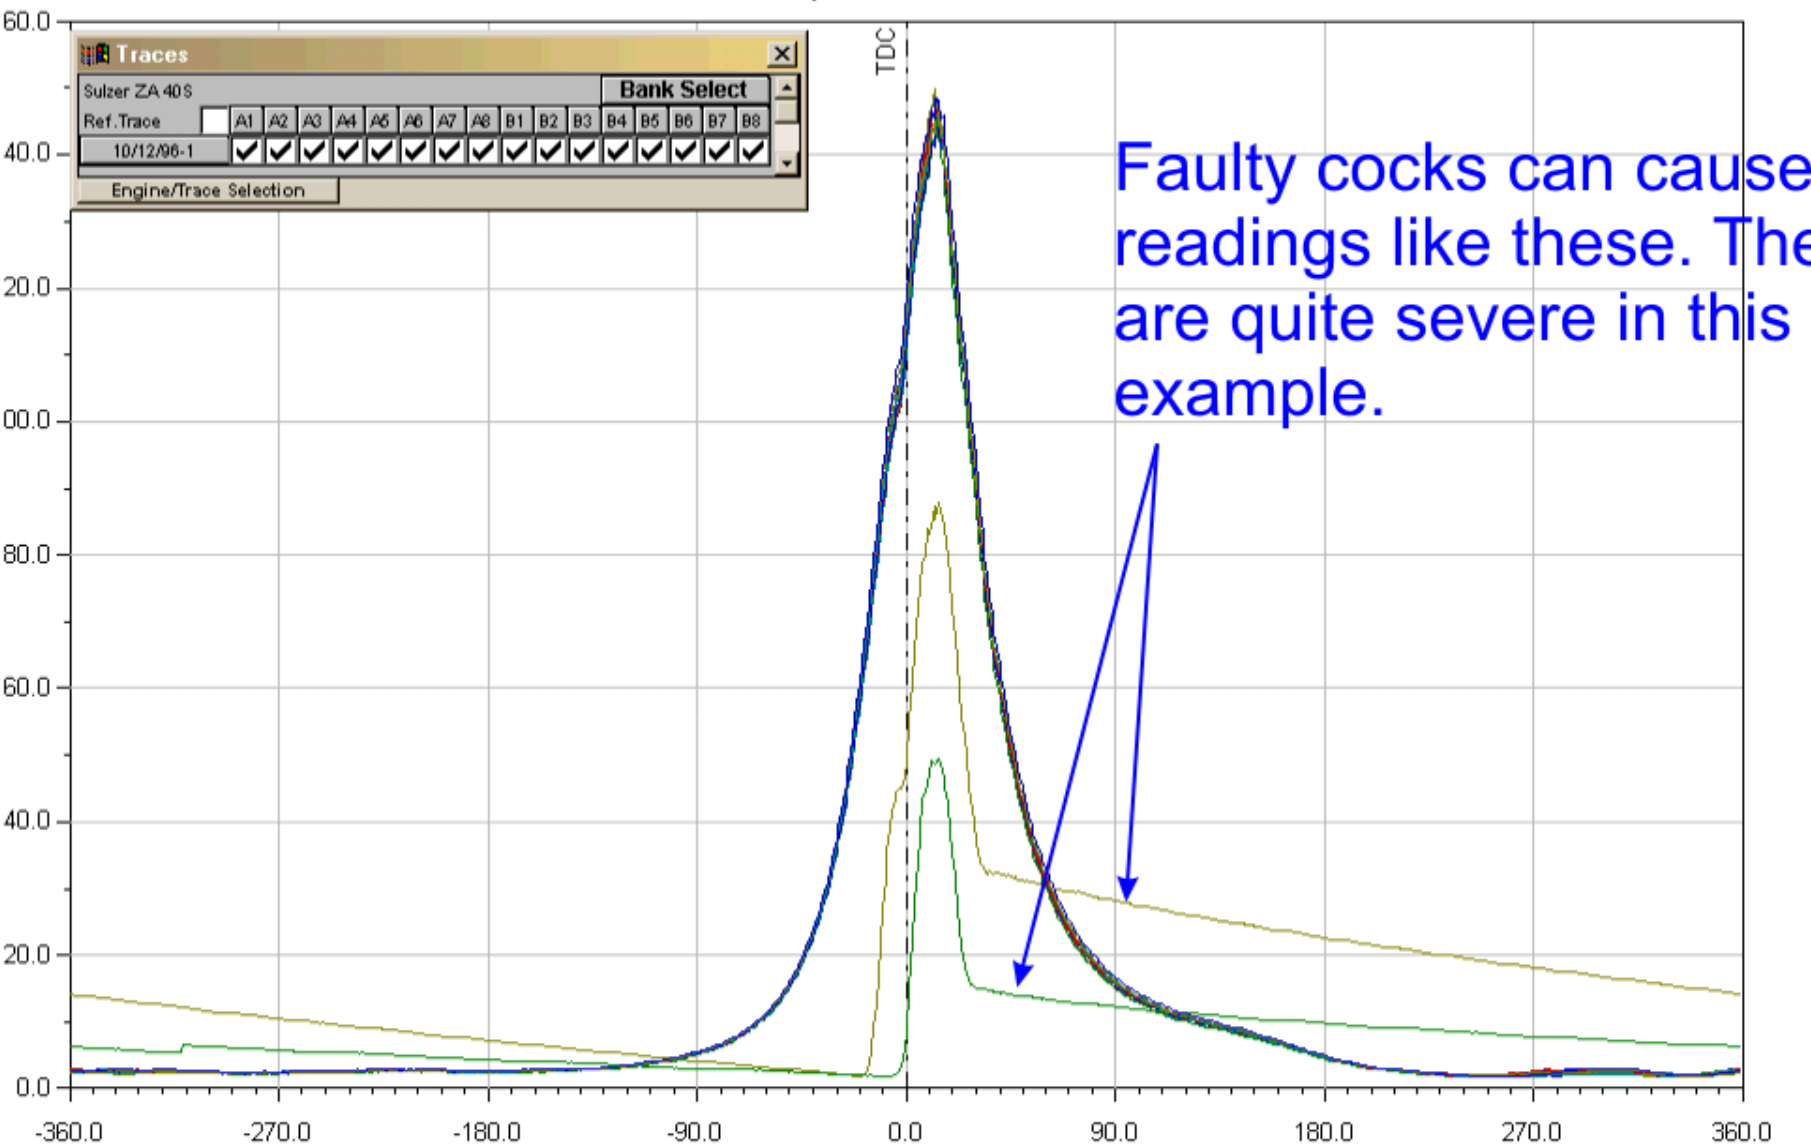
Faulty Indicator Cocks

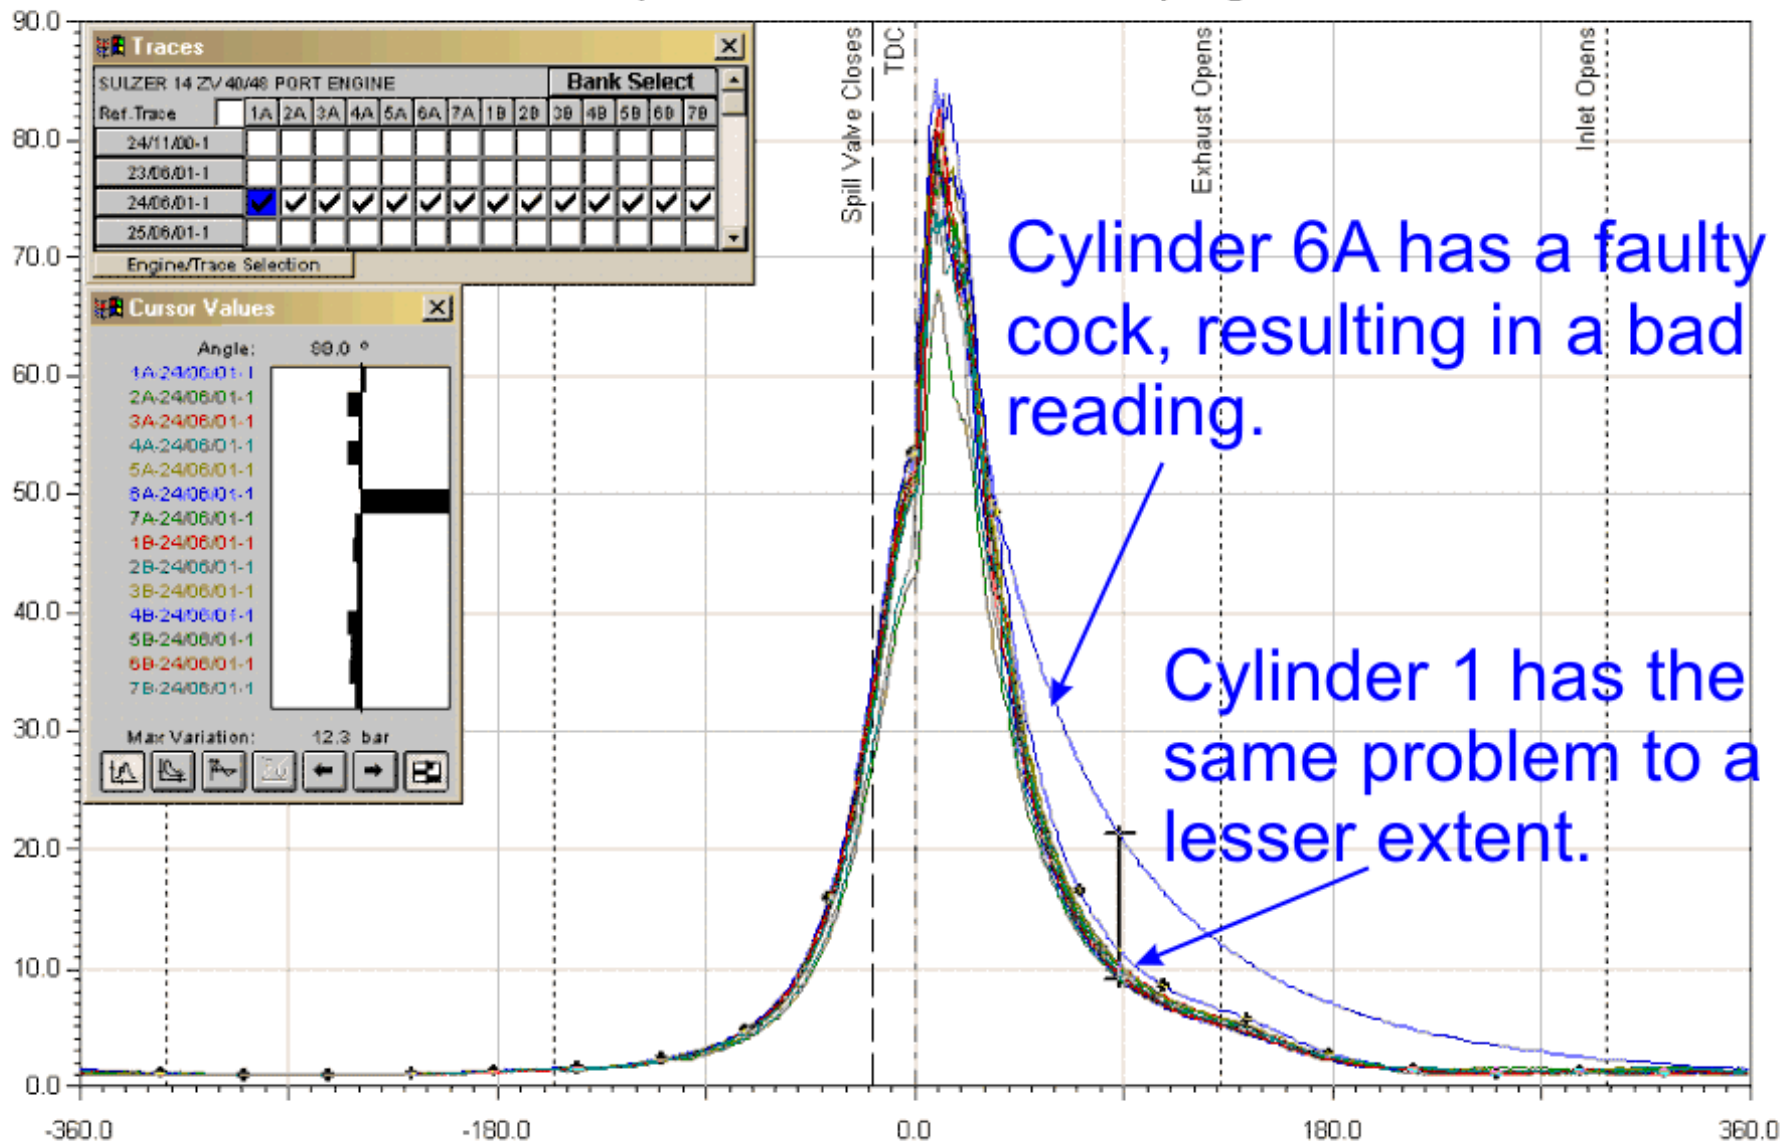
Faulty Cocks, One Severe and One Only Slight

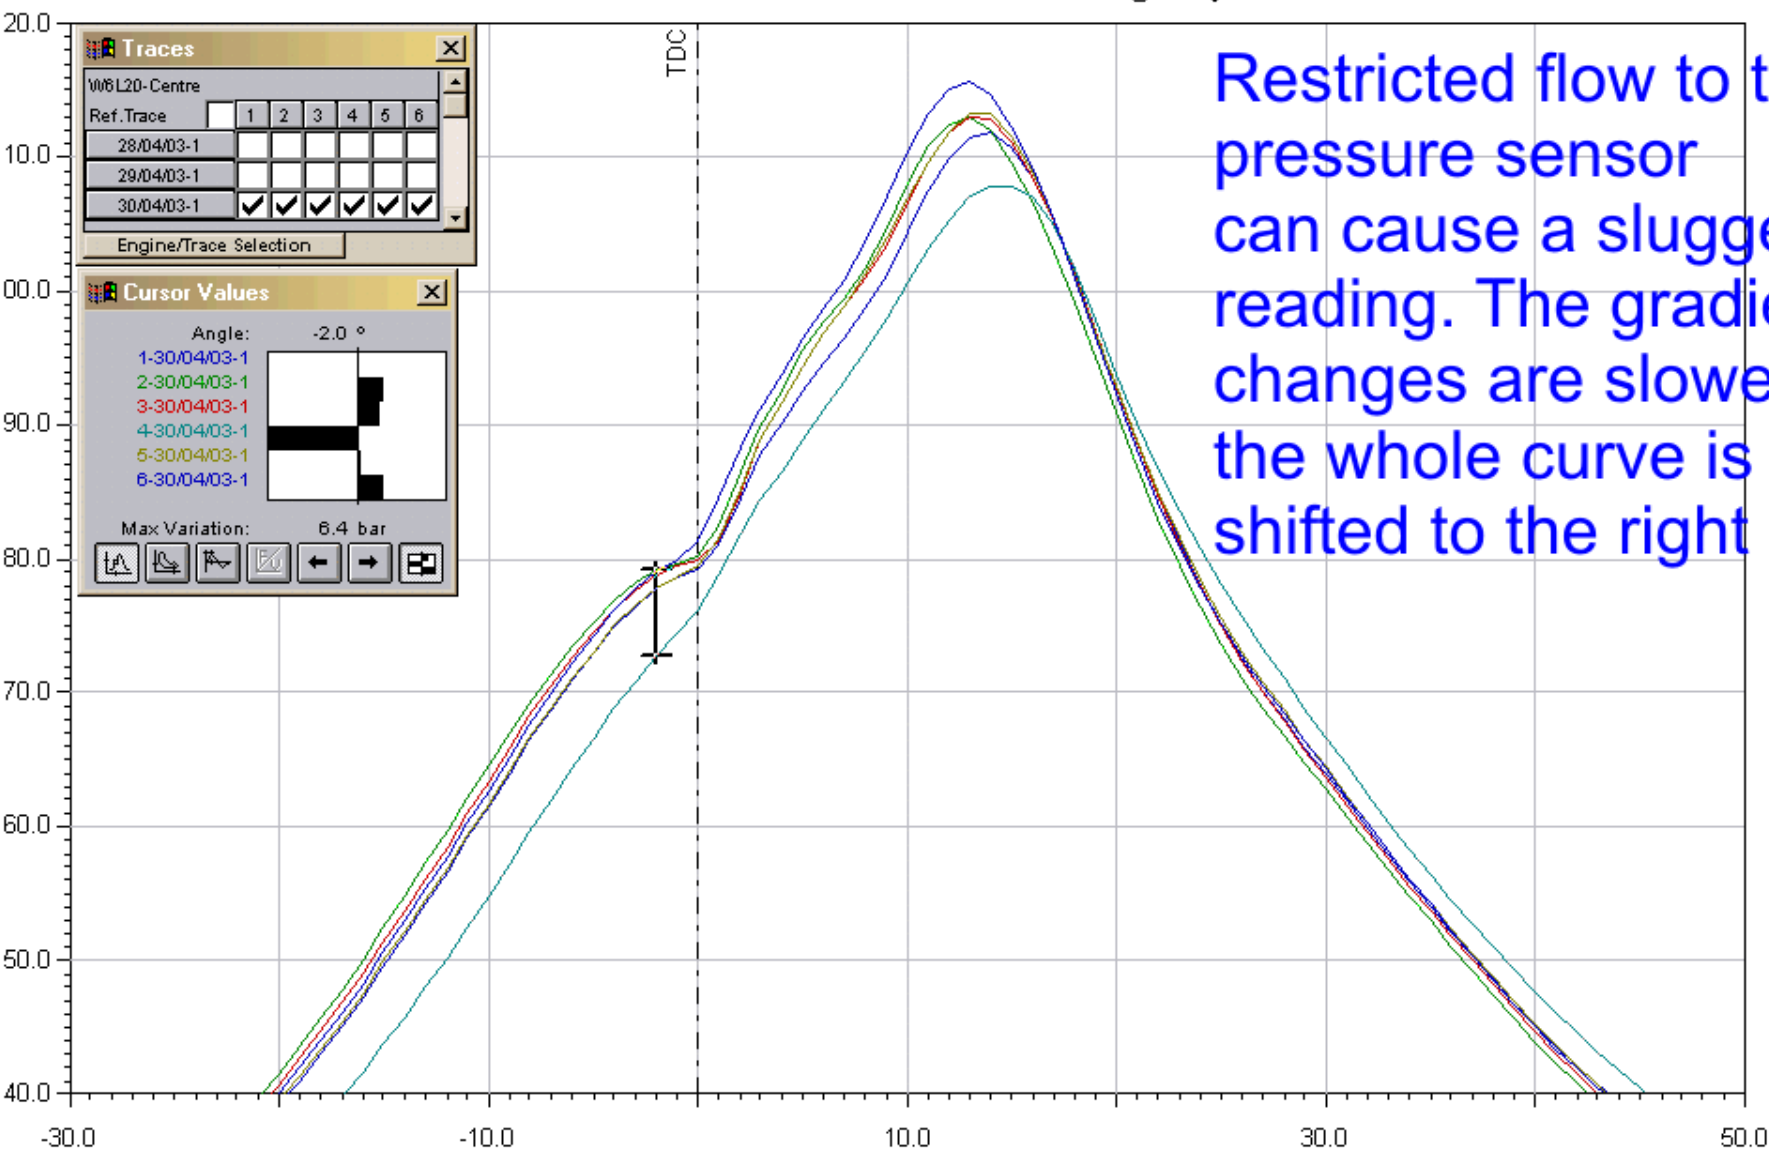
Restricted Indicator Cock or Passageway

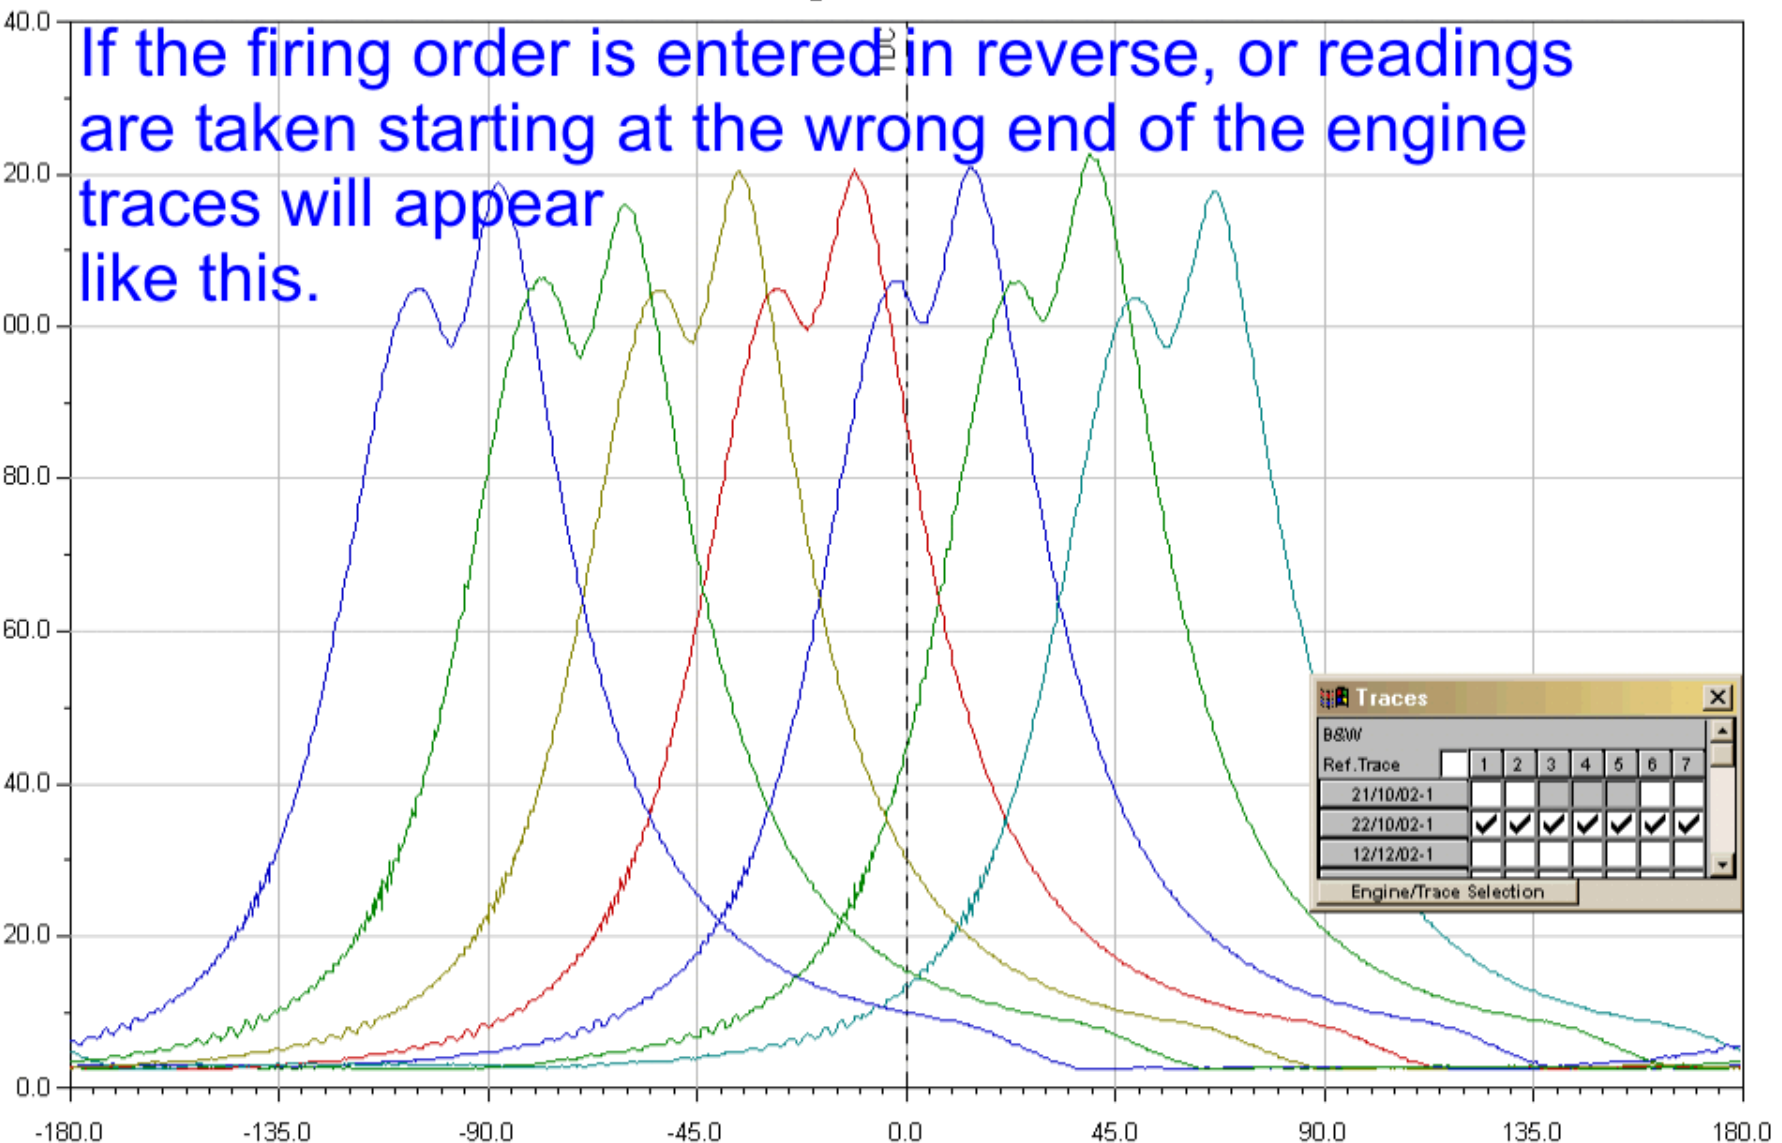
Firing Order Reversed

If the firing order is entered in reverse, or readings are taken starting at the wrong end of the engine traces will appear like this.

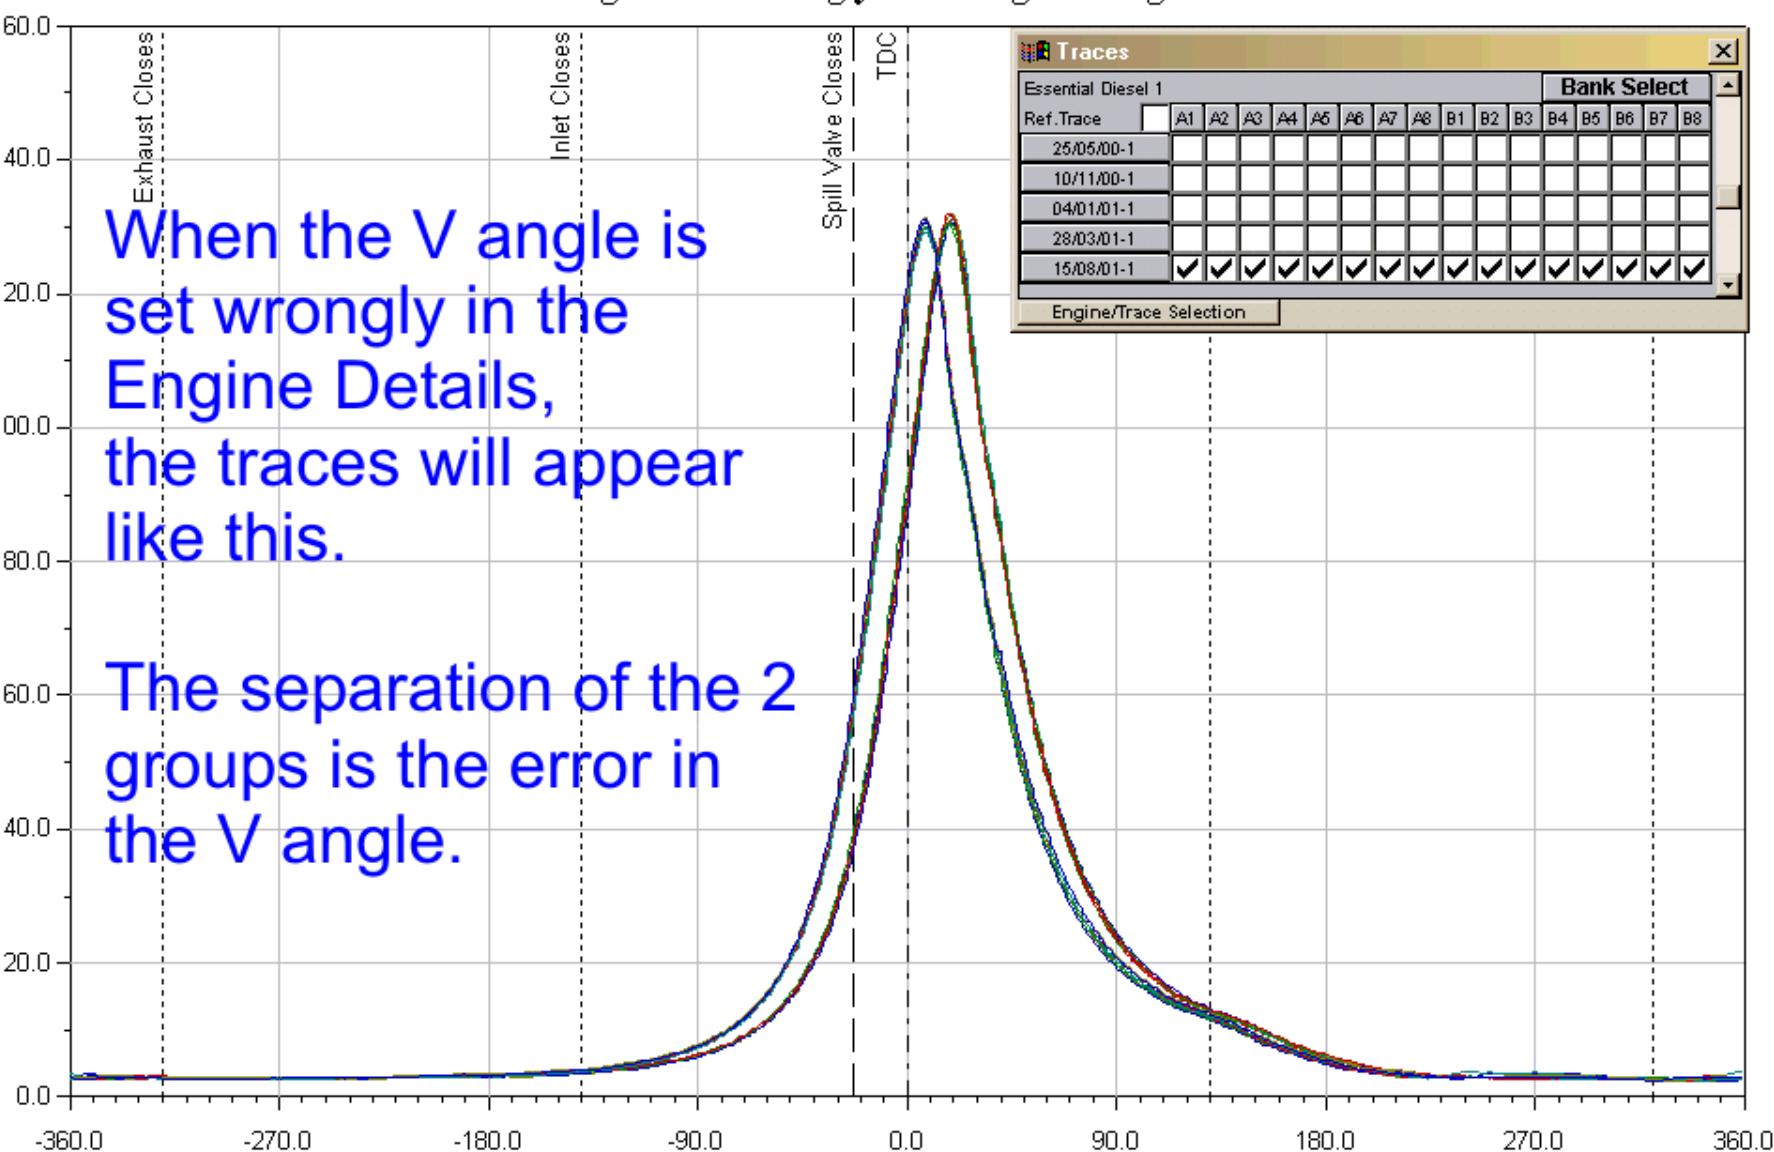
V Engine with wrongly set V Angle in Engine Data

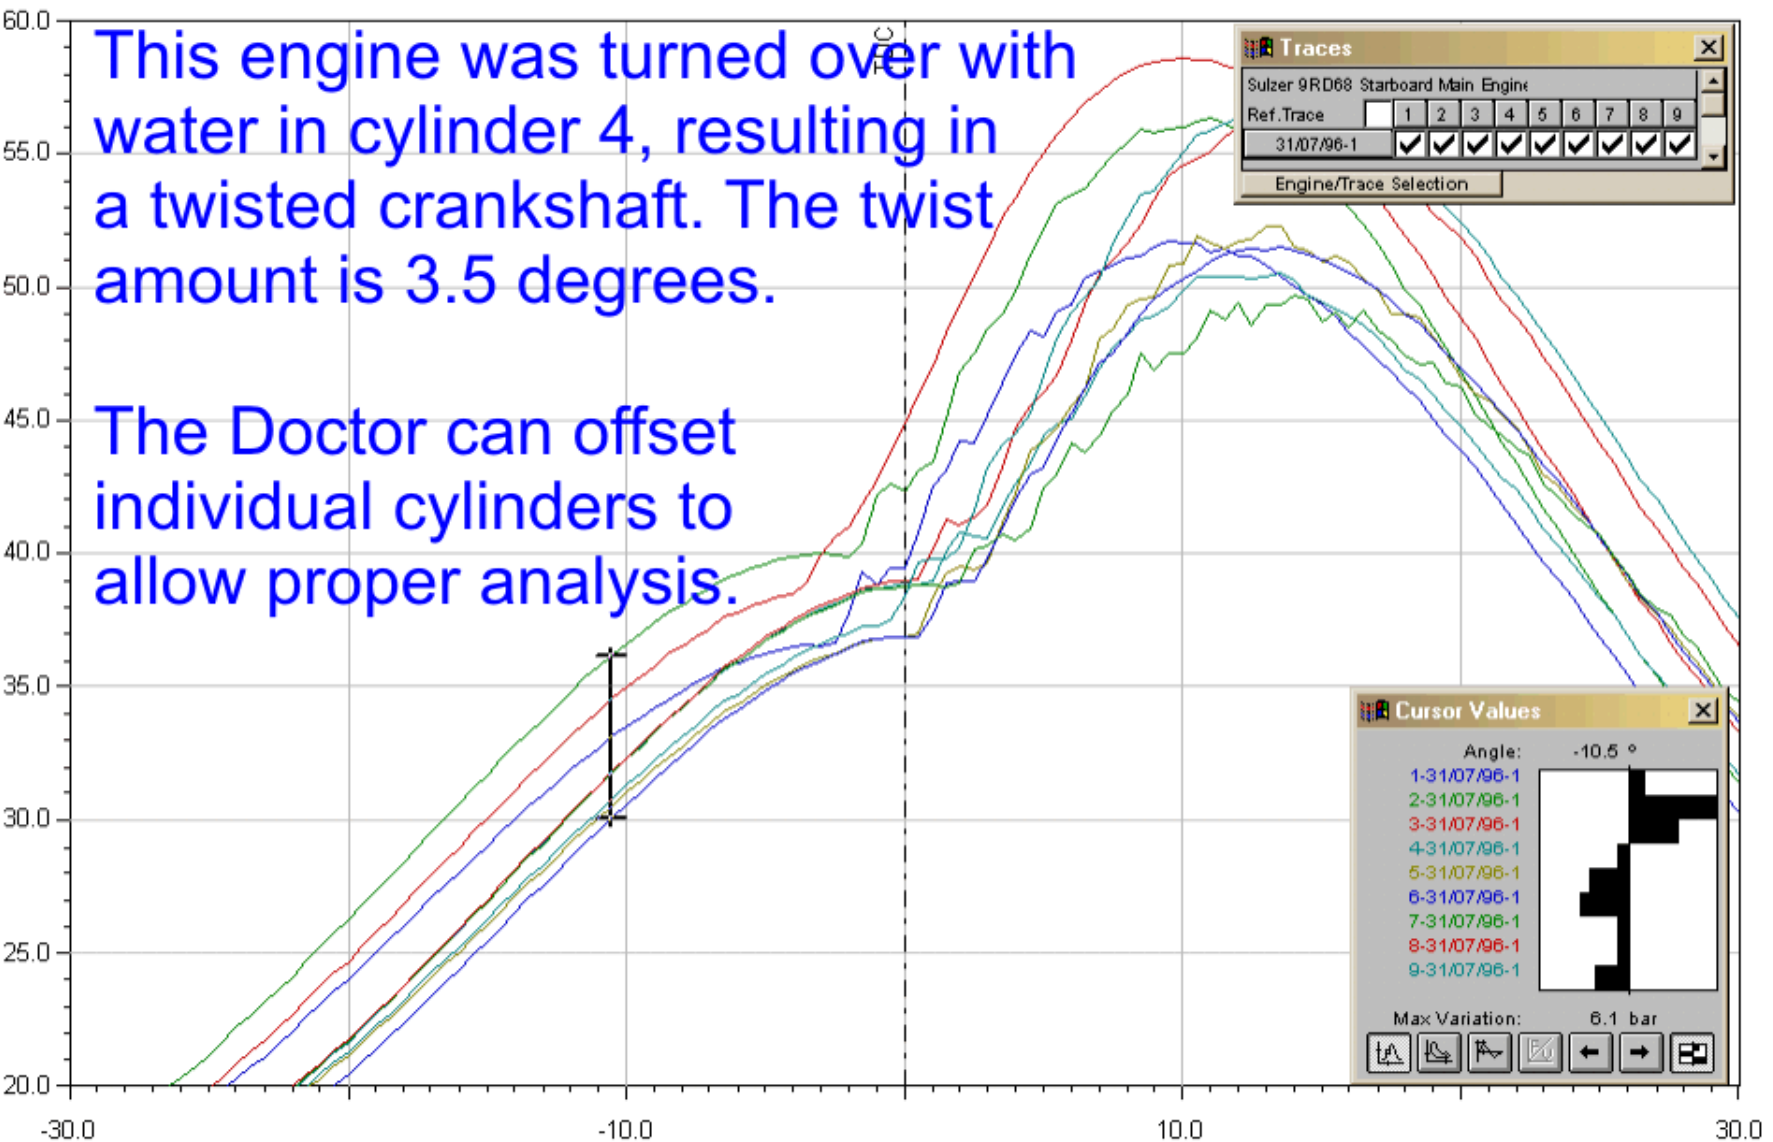
Twisted Crankshaft

This engine was turned over with water in cylinder 4, resulting in a twisted crankshaft. The twist amount is 3.5 degrees.

The Doctor can offset individual cylinders to allow proper analysis.
