Basic Analysis Tools

2-Stroke Analysis

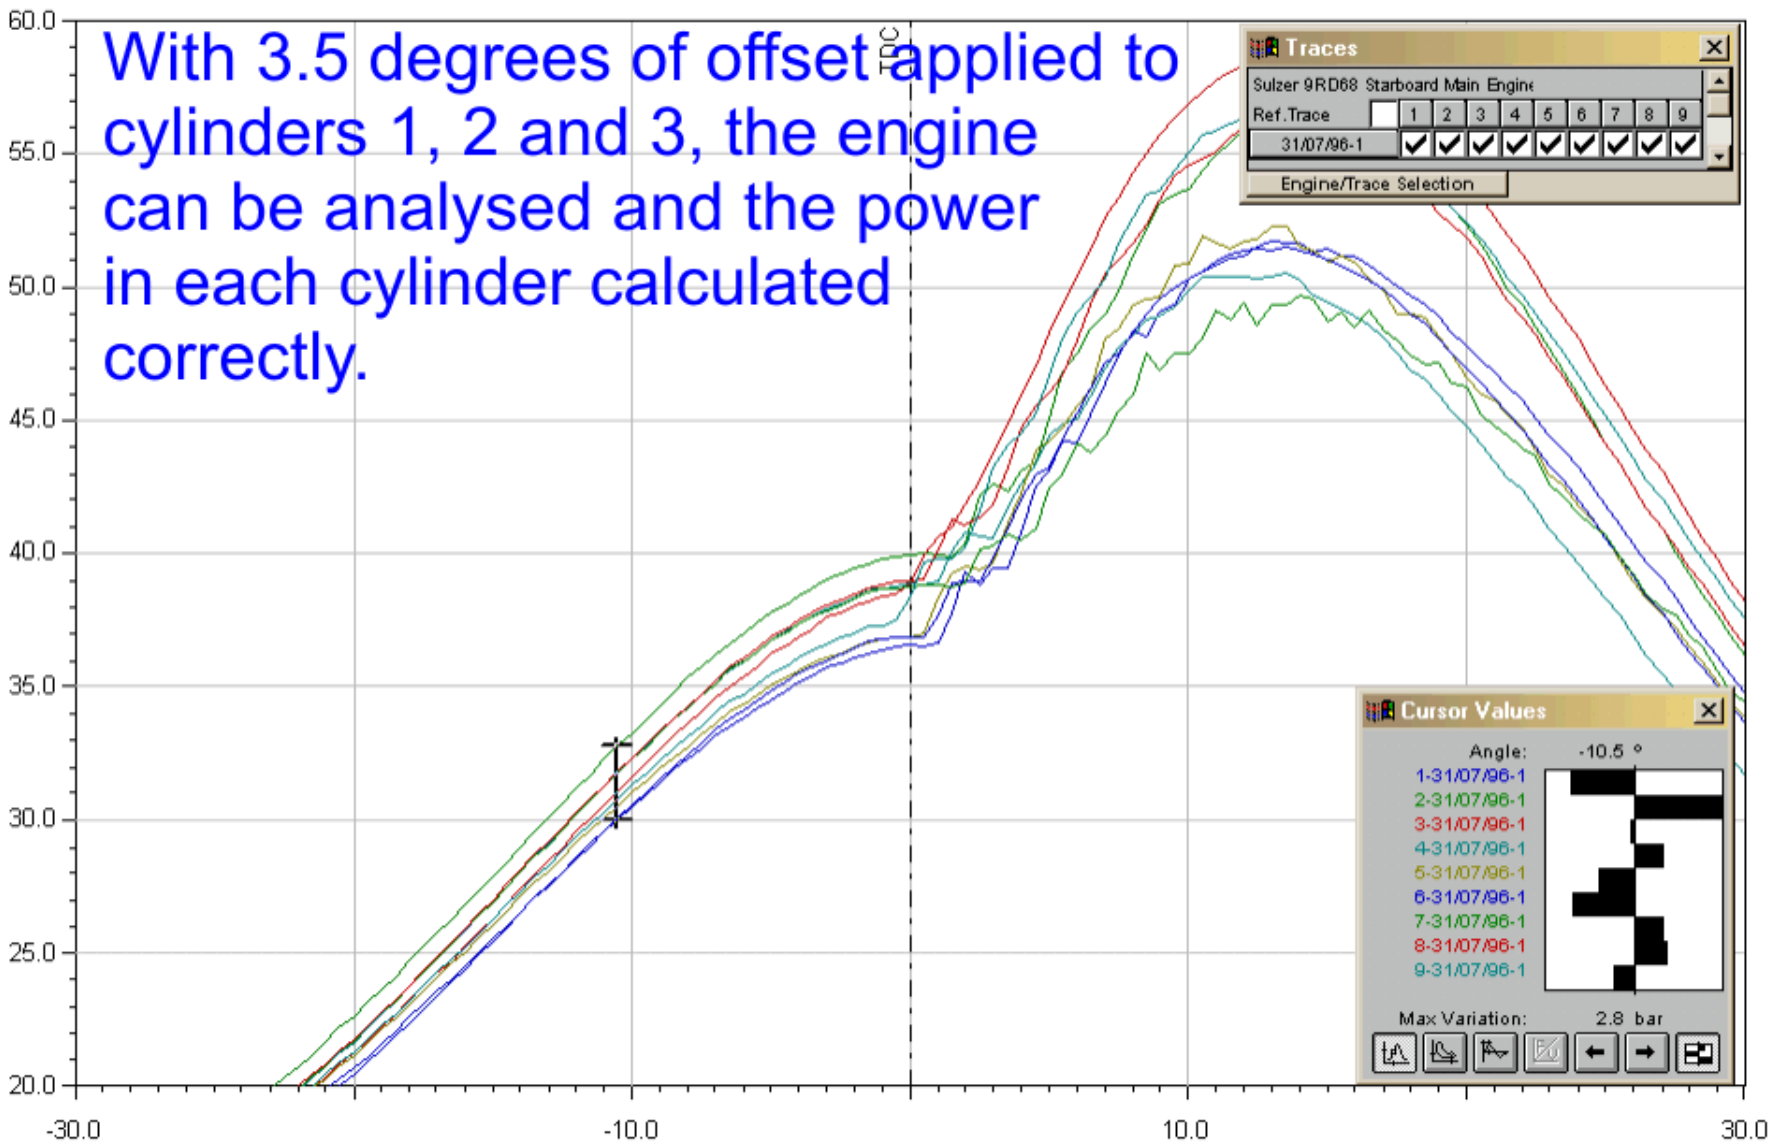
With 3.5 degrees of offset applied to cylinders 1, 2 and 3, the engine can be analysed and the power in each cylinder calculated correctly.

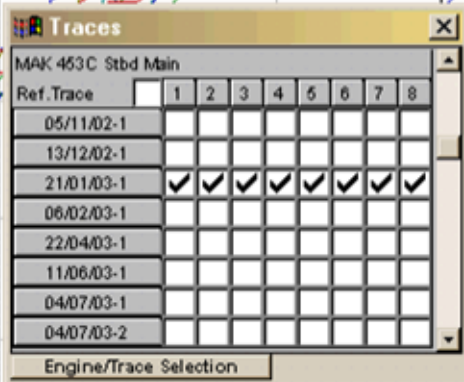
4-Stroke With Uneven Firing

An spread of the traces at TDC can indicate uneven revs on a 4-stroke engine. The solution is to fit dual crank pickups to track speed changes

Spread ~ 5 degrees

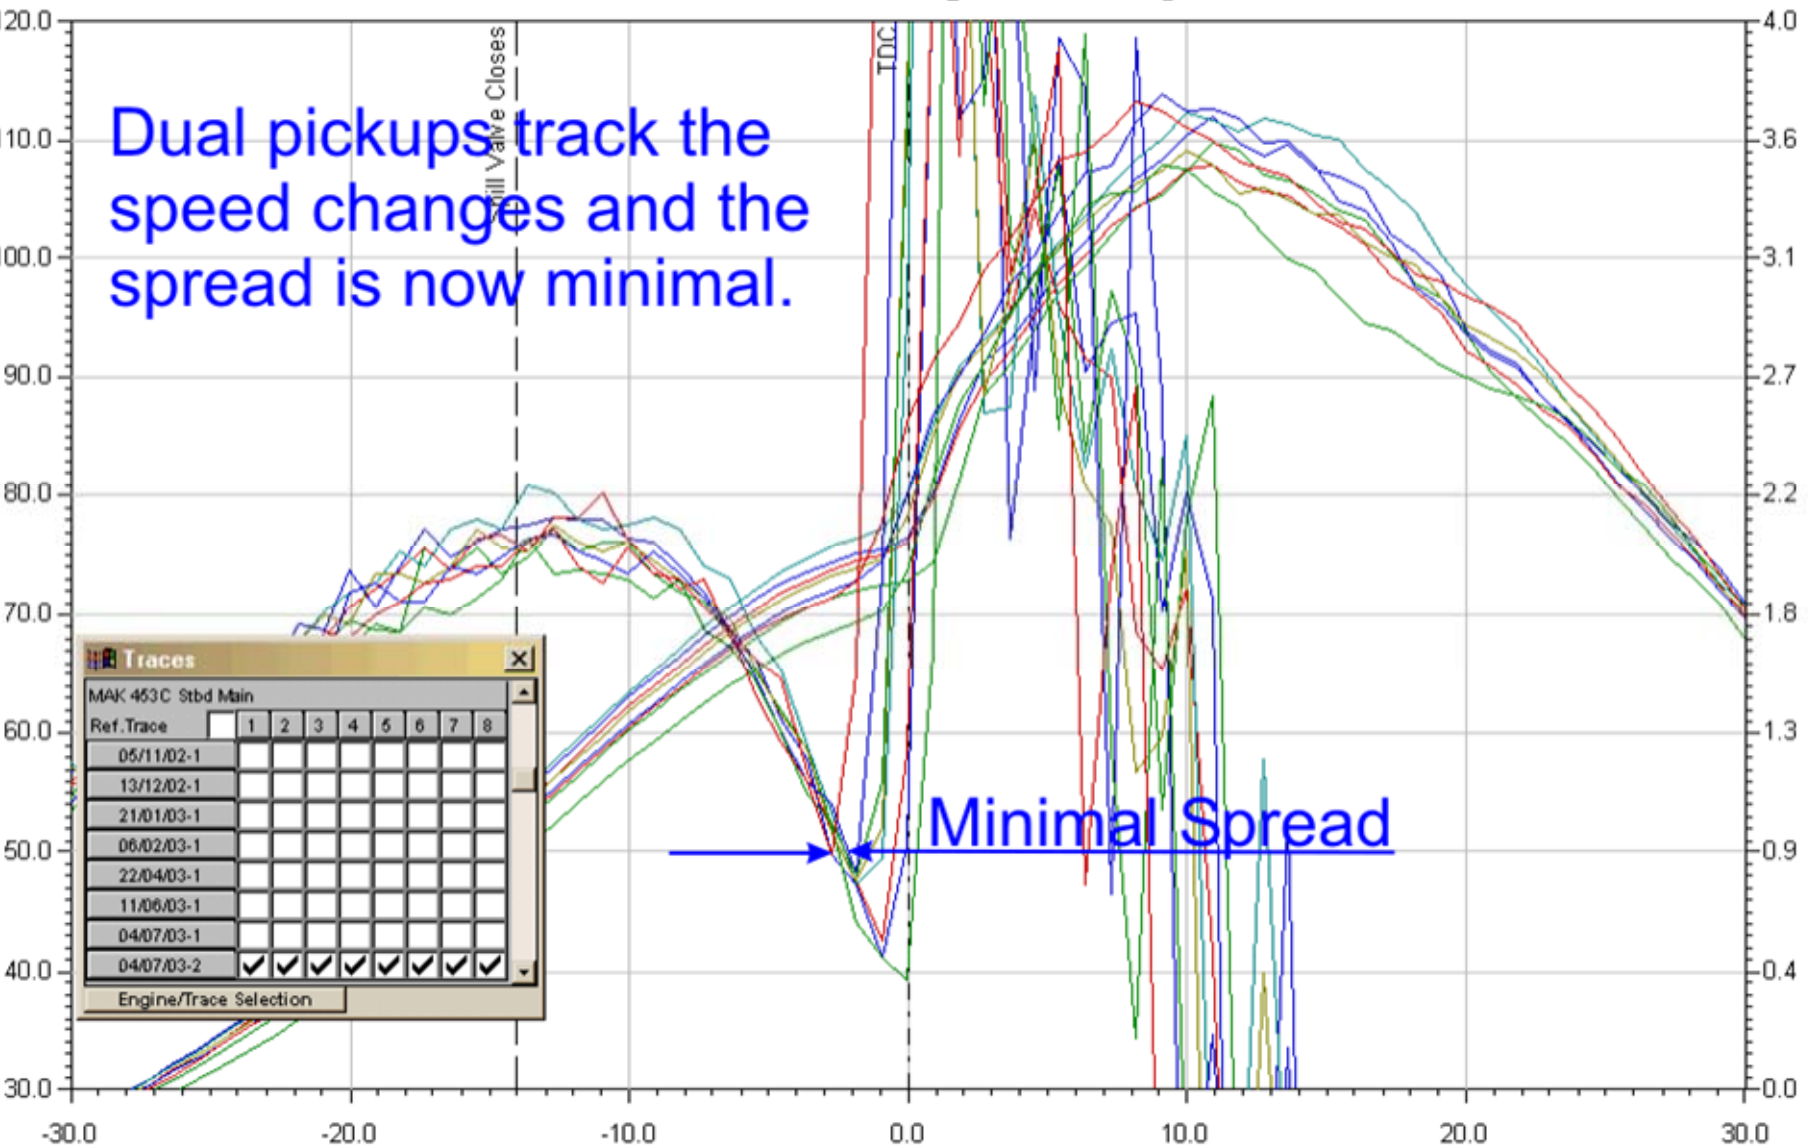
4-Stroke With Uneven Firing - Dual Pickups Fitted

Dual pickups track the speed changes and the spread is now minimal.
